# **I FACILITY CONDITION ASSESSMENT**

## **St. Dunstan's Episcopal Church**

Bethesda, MD

July 2024

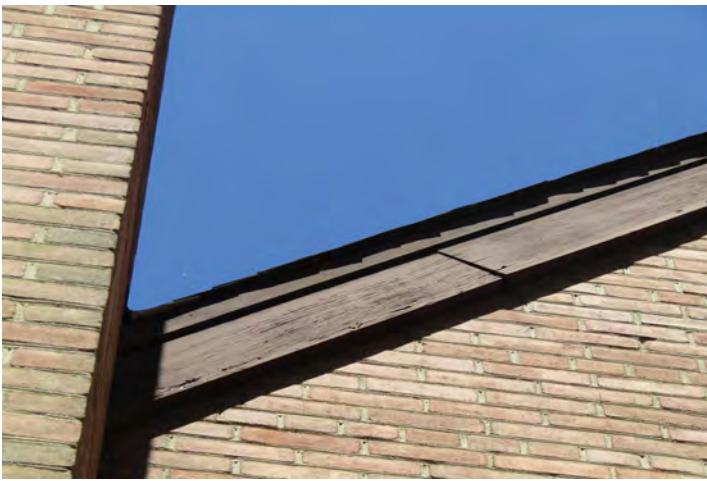
Damaged fascia

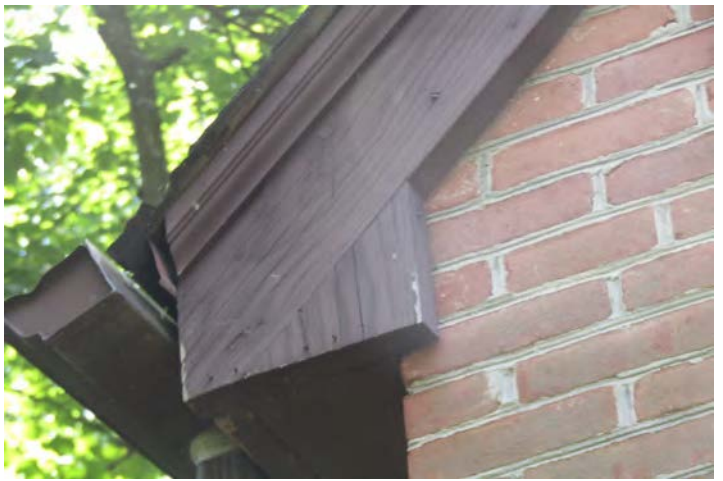
Damaged wood trim

| Capital Group | Item | Location | Potential in Current Year Dollars | Time Frame | Notes |
|---|---|---|---|---|---|
| Exterior Project | General Maintenance | Wood trim elements | \$3,025 | Immediately | Prep, prime, repair, and replace all damaged wood trim elements. Topcoat all trim to the final color. There are approximately 550 linear feet of work area, and the allowance is \$5.50 a lineal foot. |

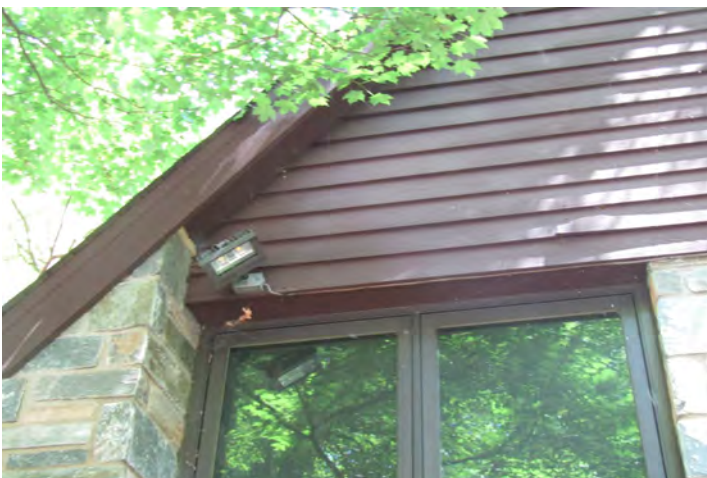
Siding has warped

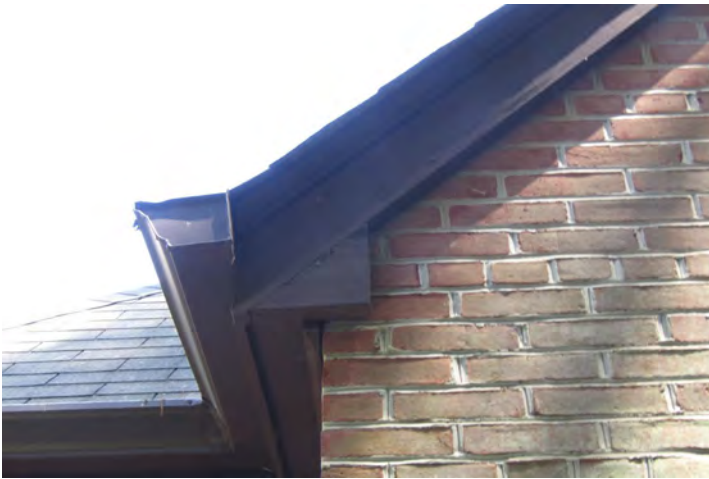
Damaged fascia

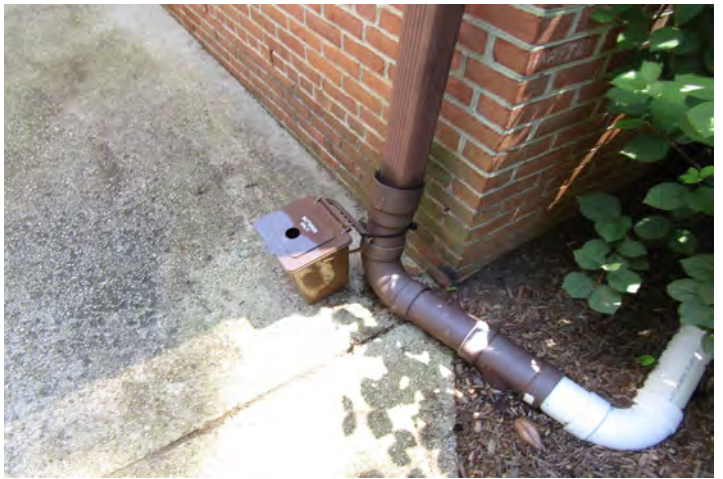
Drain has too sharp of a bend

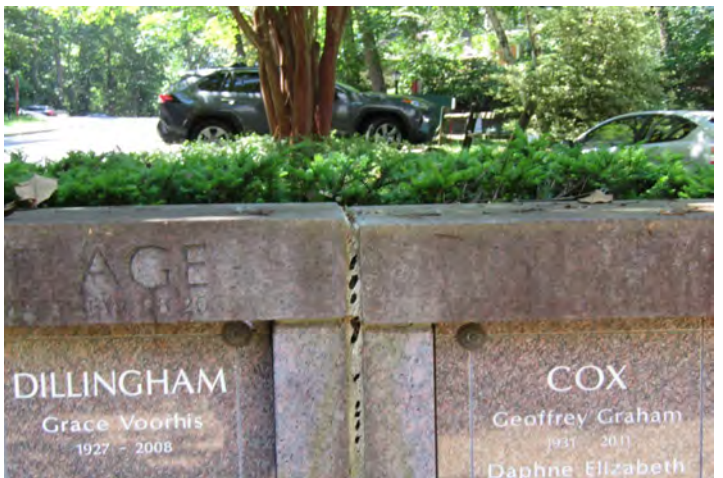
Shifting masonry or foundation at the Columbarium

| Capital Group | Item | Location | Potential in Current Year Dollars | Time Frame | Notes |
|---|---|---|---|---|---|
| Exterior Project | Masonry Repair | Campus-Wide | \$8,750 | Immediately | Stabilize the masonry and sidewalks near the Columbarium and at the basement egress window walls. |

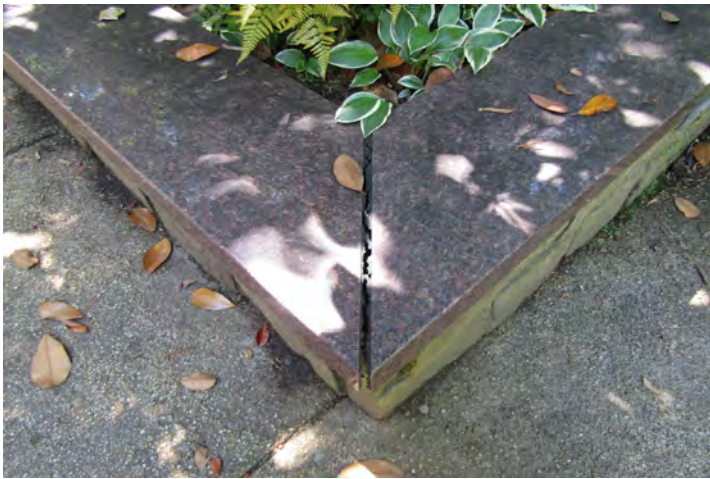
Masonry has shifted

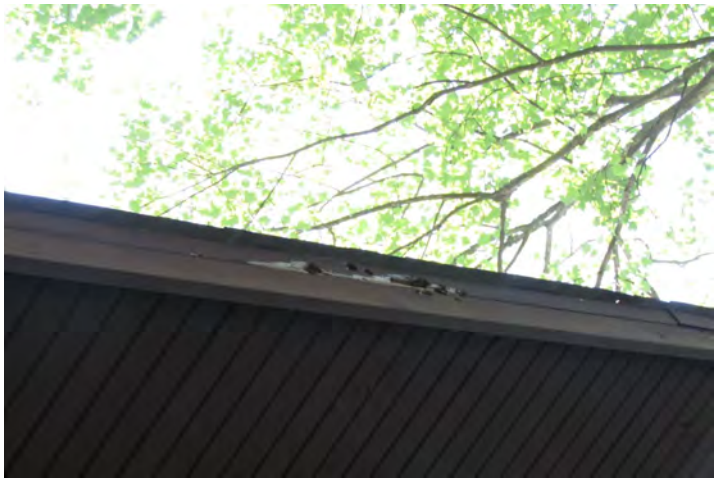
Fascia damage by insects or animals

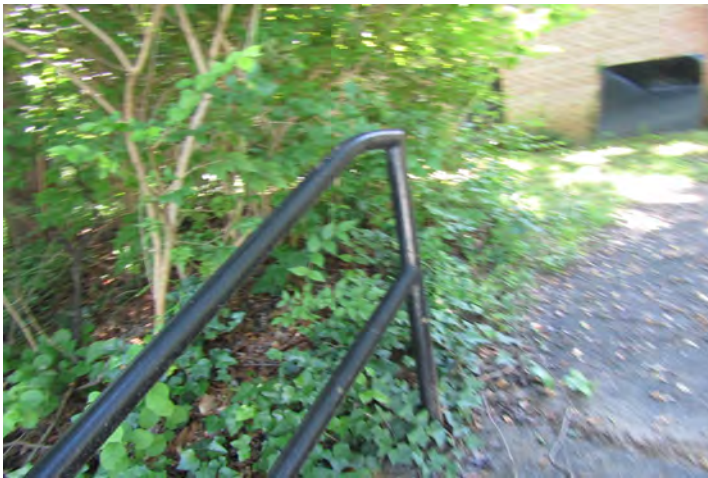
Handrail paint is chipped

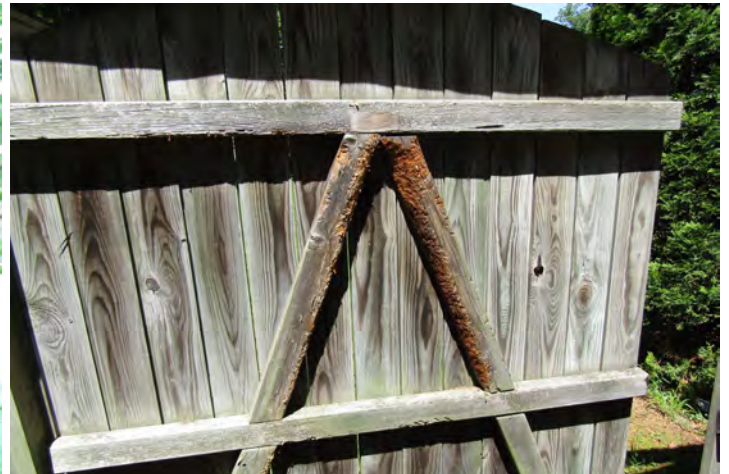
Wood damaged around the HVAC

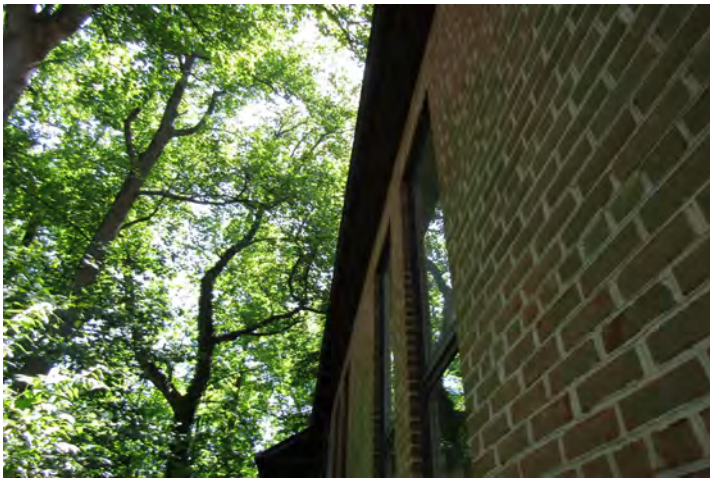
Trees are growing too close to the building

| Capital Group | Item | Location | Potential in Current Year Dollars | Time Frame | Notes |
|---|---|---|---|---|---|
| Exterior Project | Landscaping | Campus-Wide | \$12,500 | Immediately | Thin and trim trees, reduce landscaping, trim back from the facility. Certified arborist and licensed landscaper recommended. |

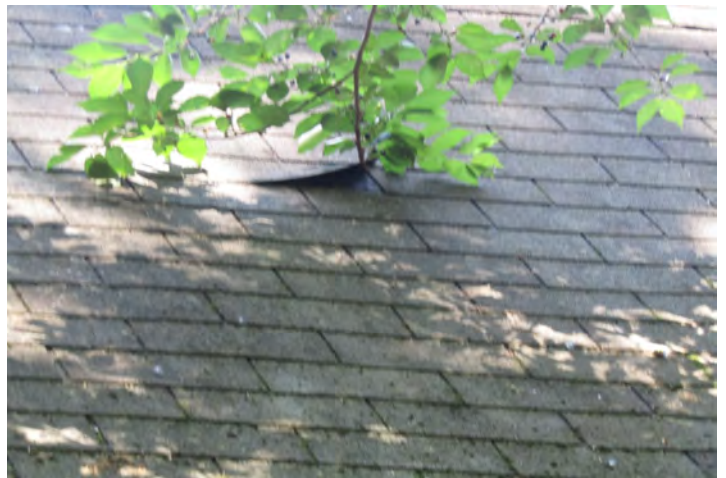
Tree branch growing in the shingles

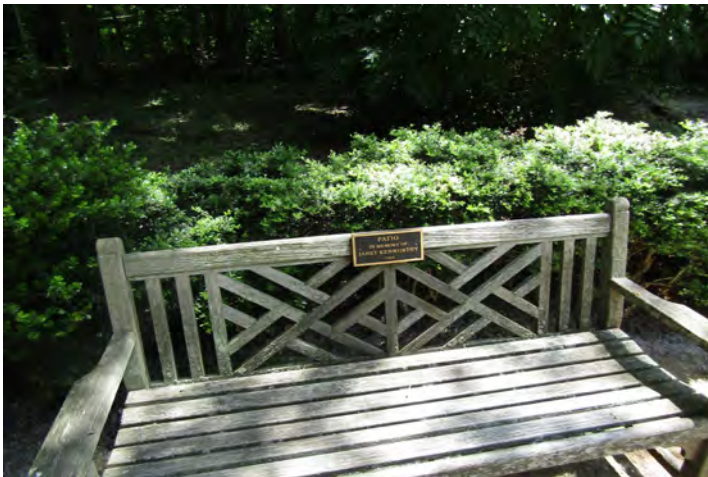
More benches would be helpful

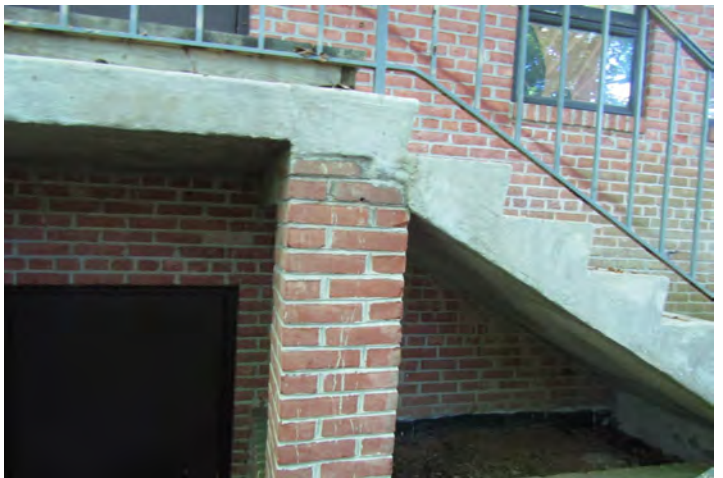
Exit steps need cleaning and repair

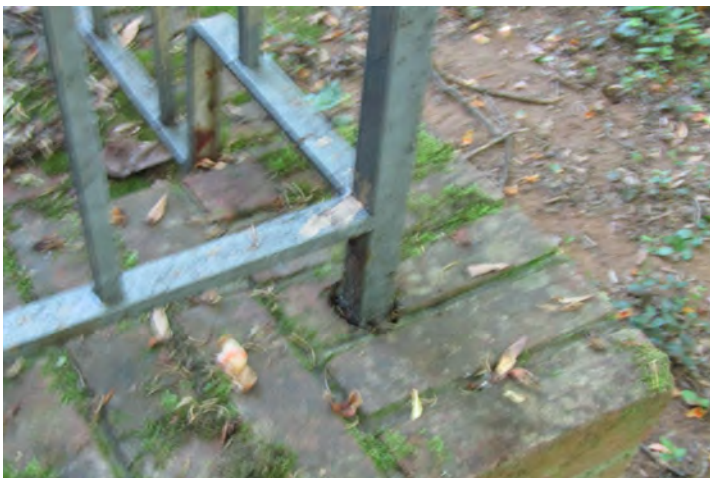
Handrail post base is damaged and missing grout

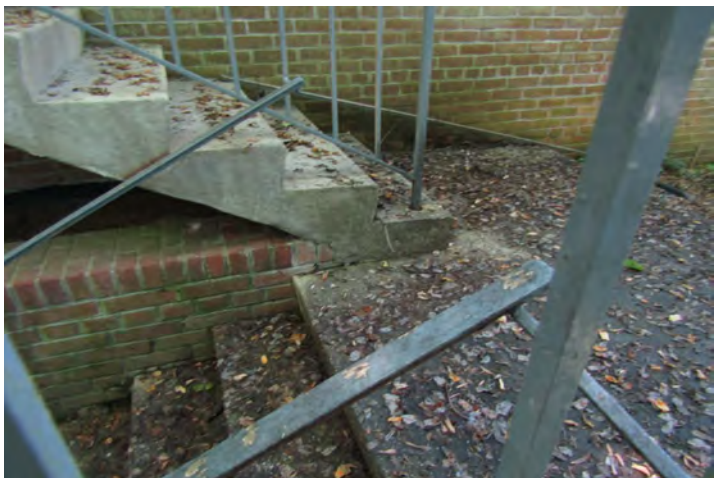
Metal railings are chipped

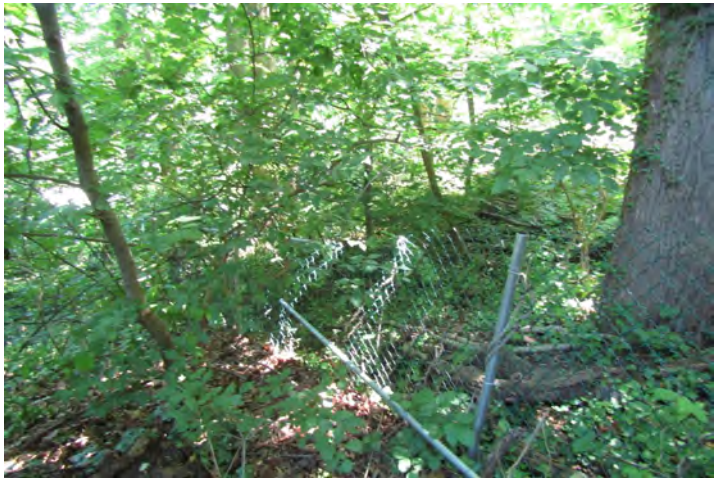
Chain-link fence is damaged

| Capital Group | Item | Location | Potential in Current Year Dollars | Time Frame | Notes |
|---|---|---|---|---|---|
| Exterior Project | Fence repair | Playground and east side | \$2,750 | Immediately | Repaint and straighten playground fence, repair the east boundary fence. |

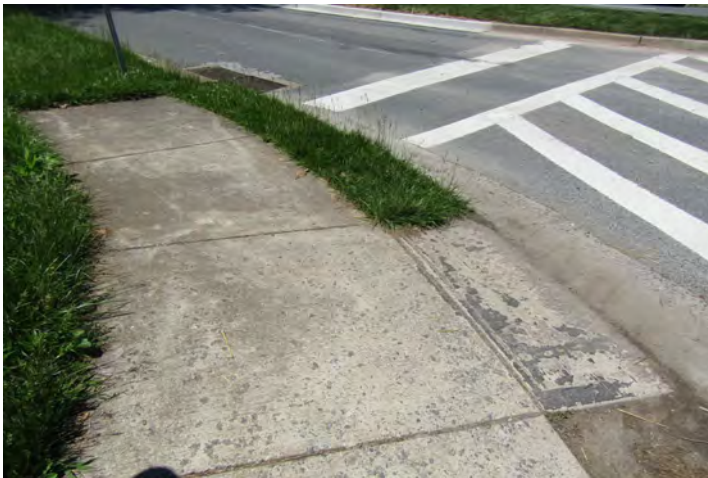
Runoff from the hill impacts city sidewalk

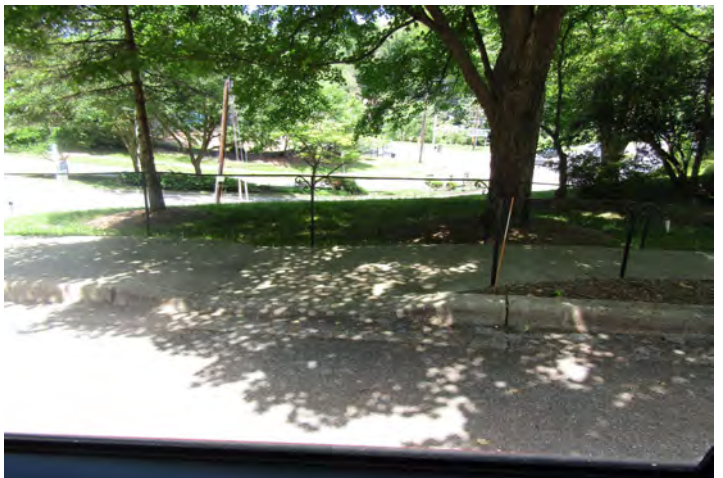
Curb cut is not well marked

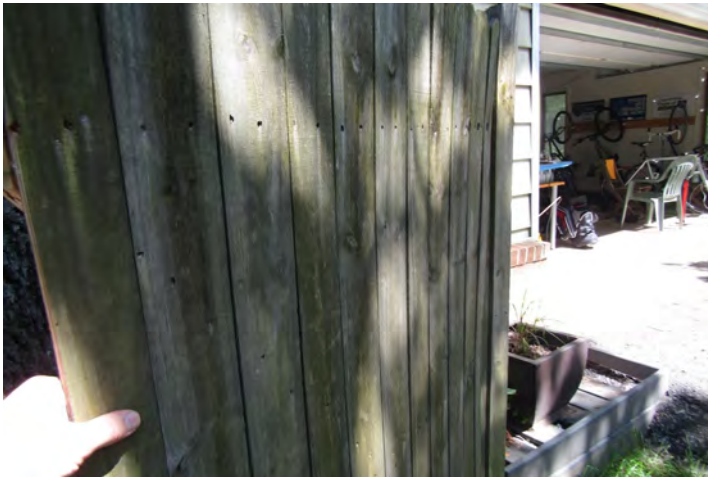
Fencing needs cleaning

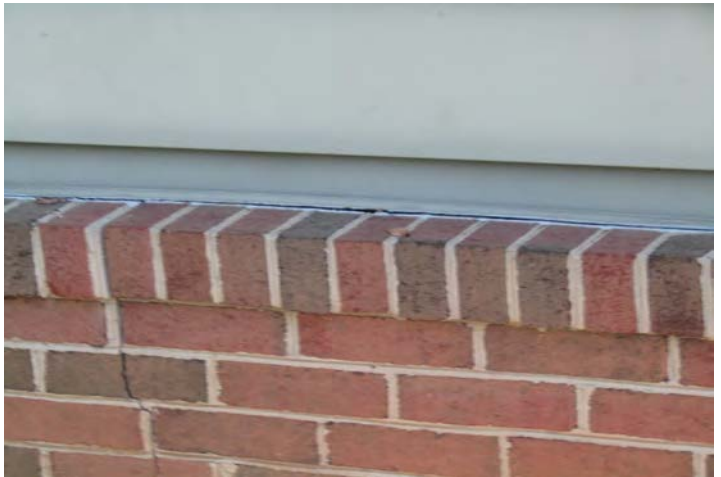
Caulking line has failed

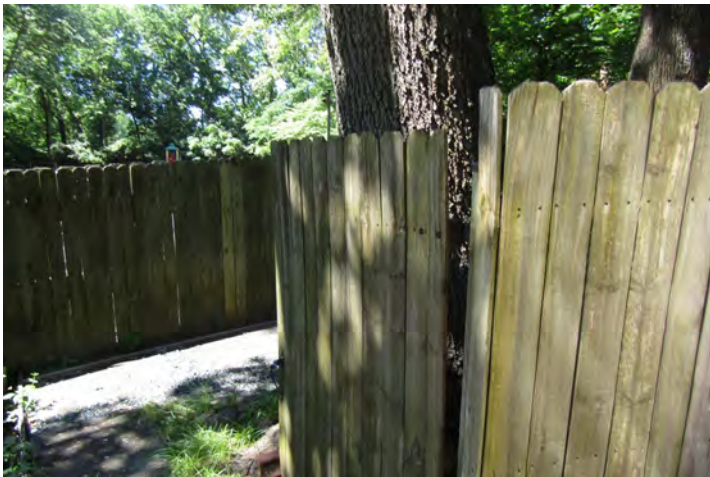
Fencing needs cleaning and resealing

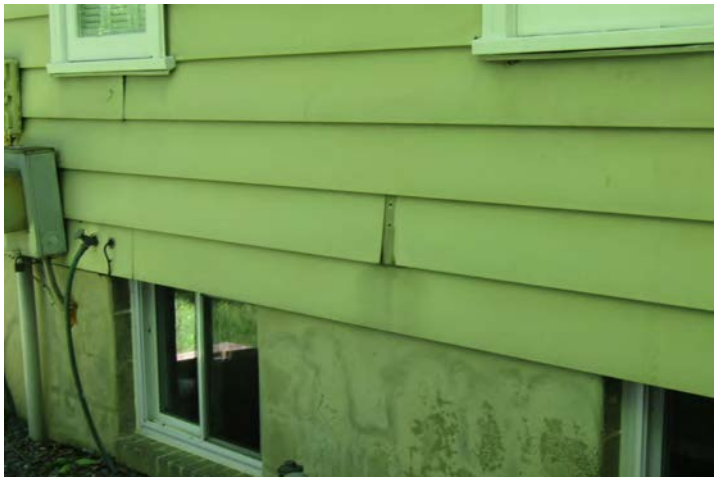
Minor areas of repair needed on the siding

| Capital Group | Item | Location | Potential in Current Year Dollars | Time Frame | Notes |
|---|---|---|---|---|---|
| Exterior Project | Siding repair and cleaning | Parsonage | \$7,500 | Immediately | Repair all areas of the siding that are damaged or loose. Softwash the exterior of the parsonage and garage. Recaulk all joints. |

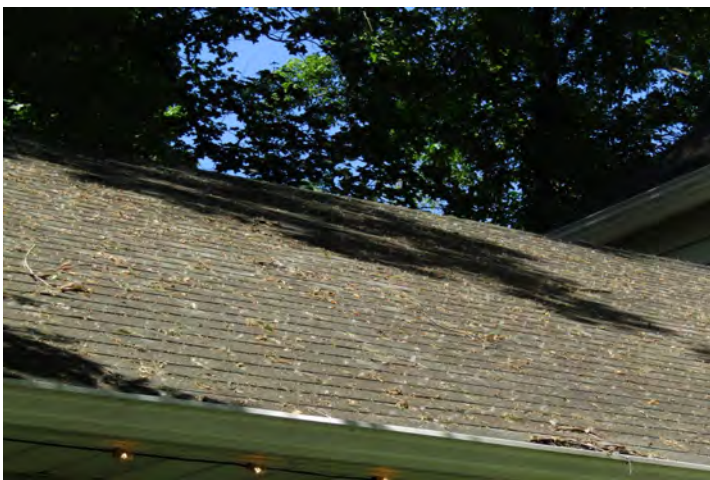
Roof is at or near service life

| St. Dunstan's Episcopal Church | | | | | |
|---|---|---|---|---|---|
| Roofing | 24 squares of roofing | Parsonage | \$23,869 | Immediately | The roof is at the end of its expected life. We recommend replacing approximately 24 squares of shingles with Class-3 dimensional shingles, synthetic underlayment, ice and water shield on the edges and valleys, and all associated trim and flashing. We estimate \$1000 per square turn-key. |

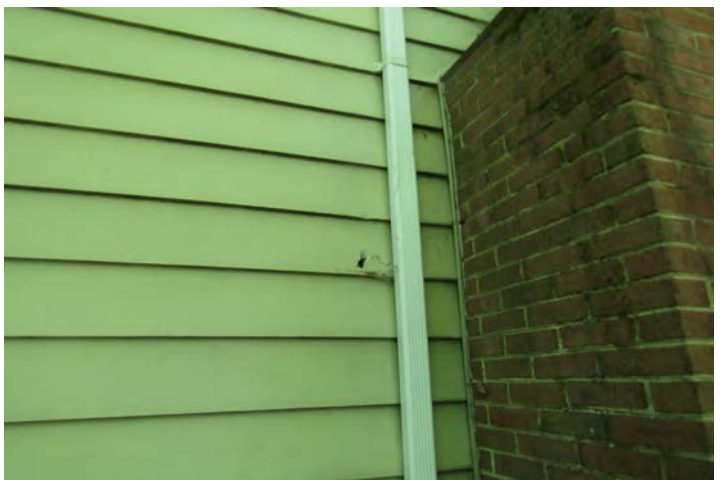
Siding damage

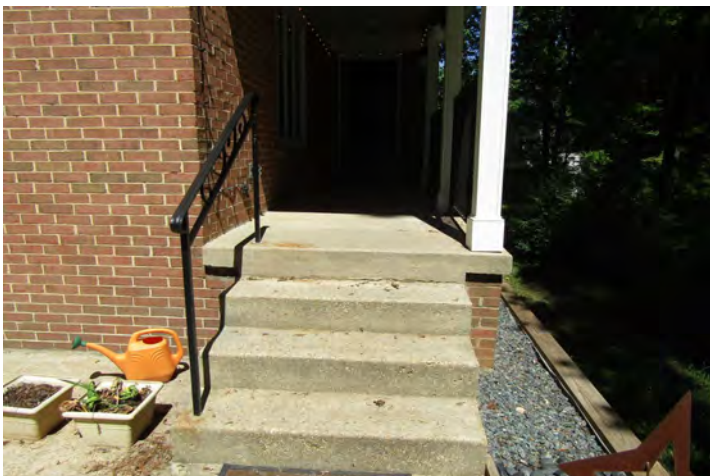
Stairs should have two handrails

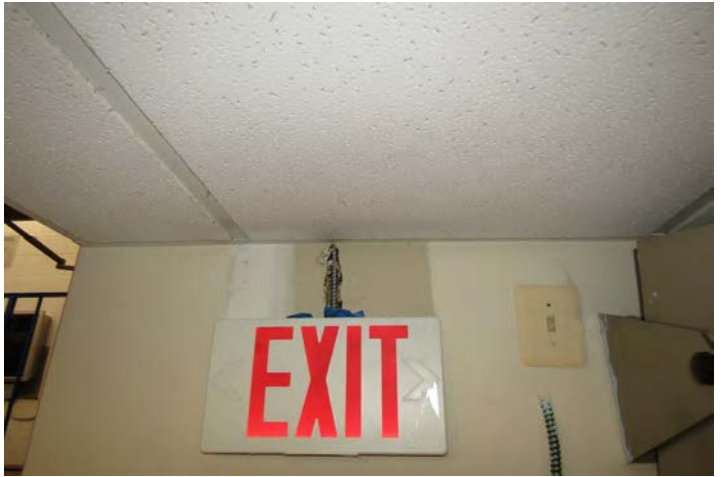
Improper MC8 installation and wall needs touchup

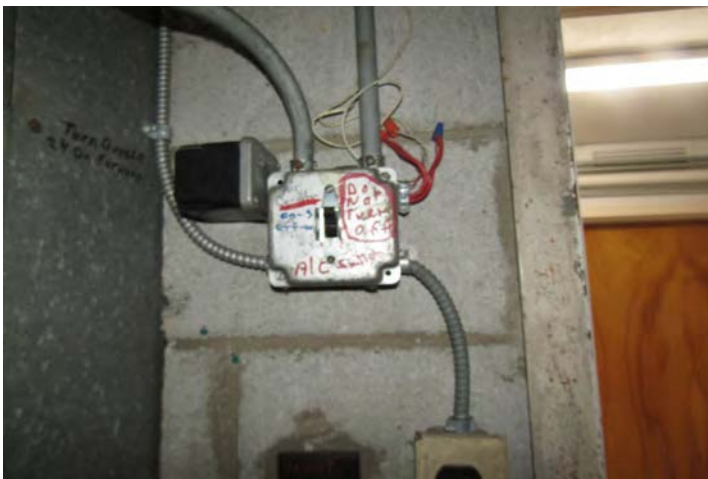
Improperly contained wires

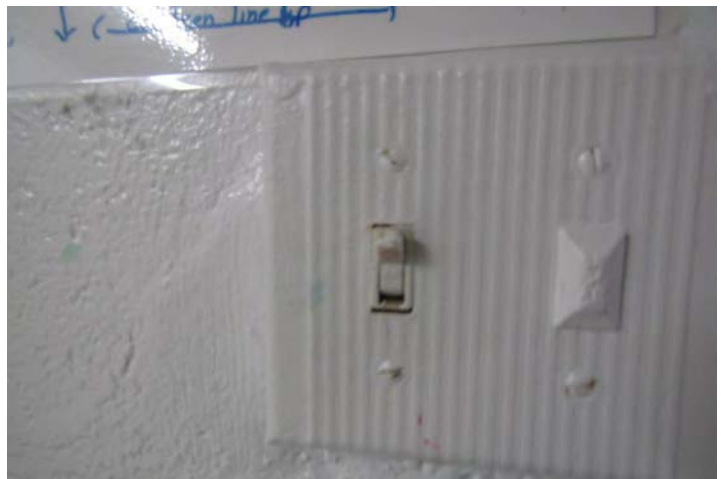
Switch plat and switch has been painted

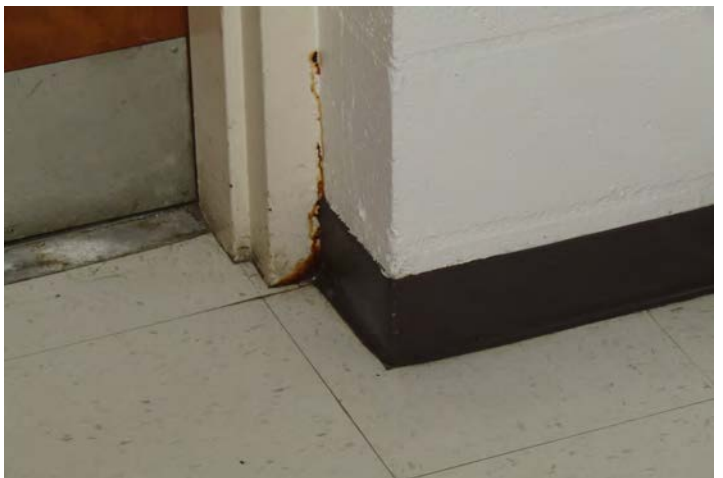
Rust and staining on the door frame

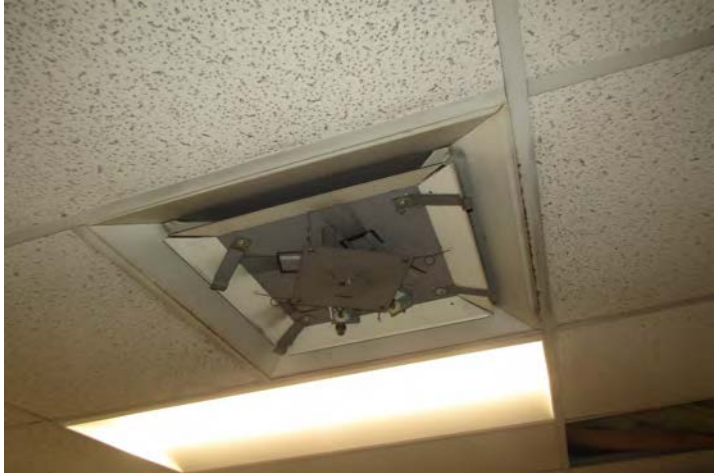
Broken HVAC supply vent

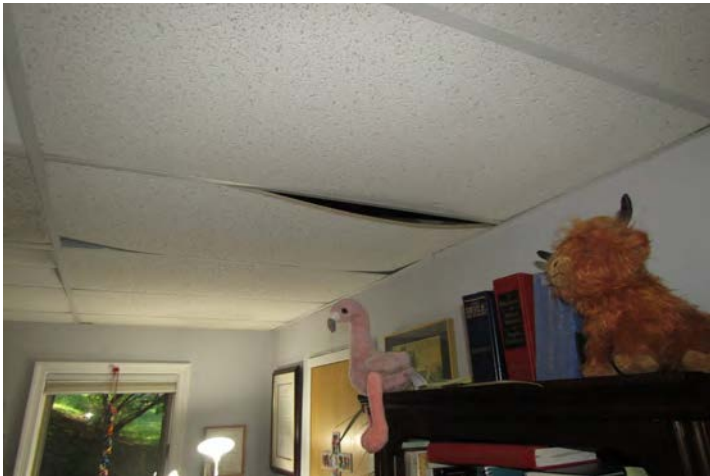
Ceiling tiles out of place

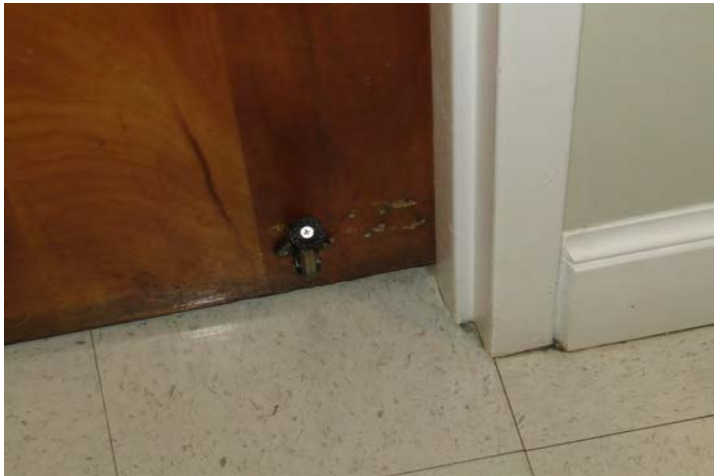
Door damage at the bottom

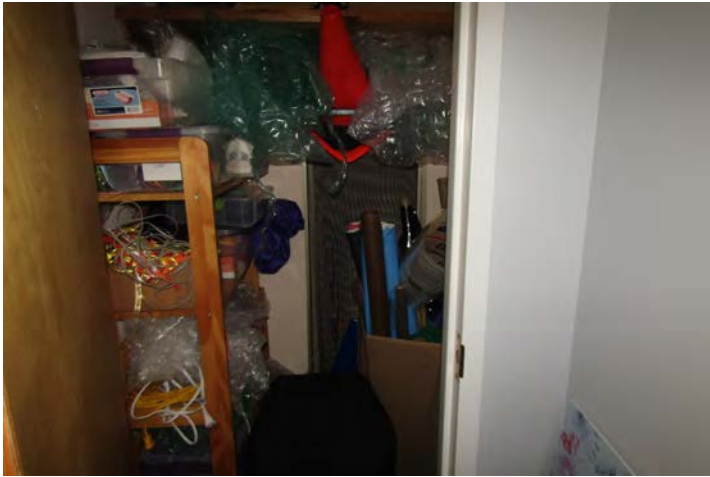
Haphazard storage

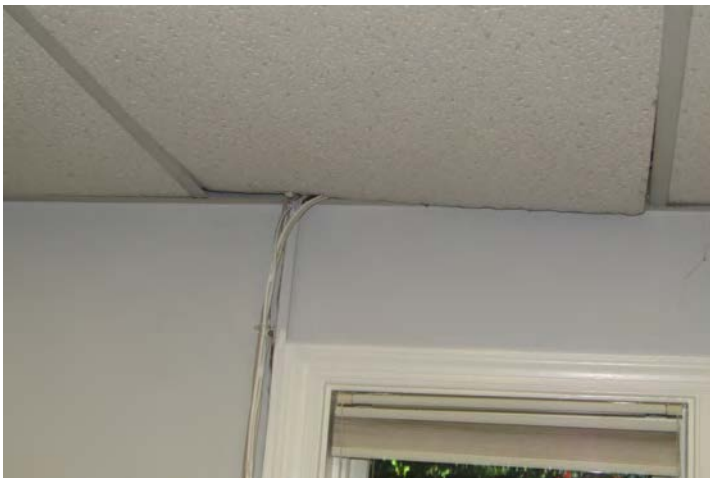
Improper cable access through the ceiling tile

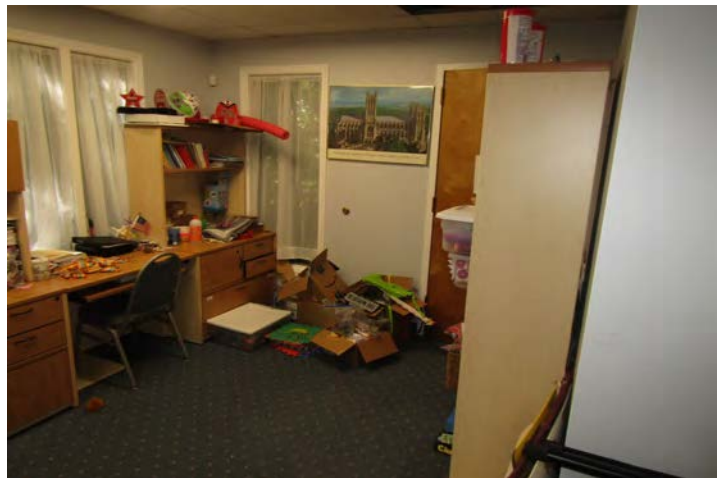
Lack of storage options

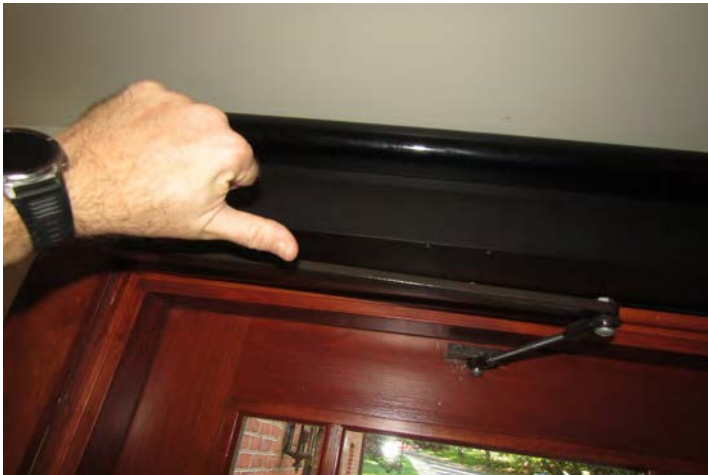
Door timing is too short

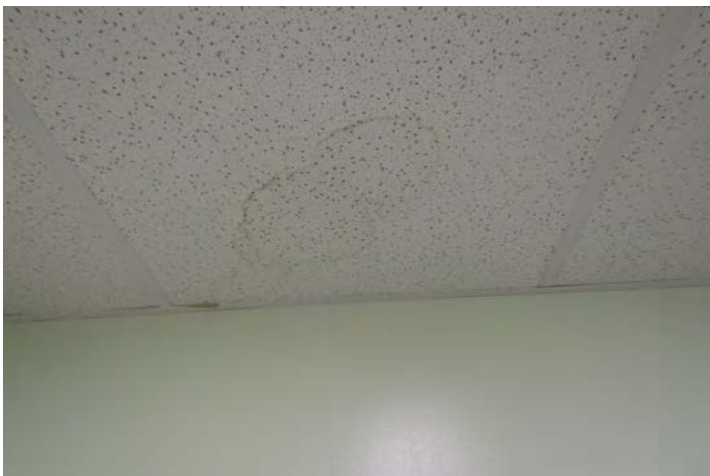
Stained ceiling tile

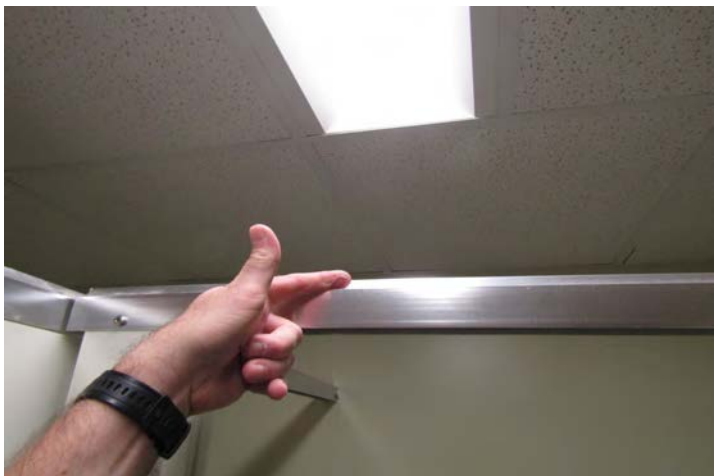
Debris buildup on the partition structure

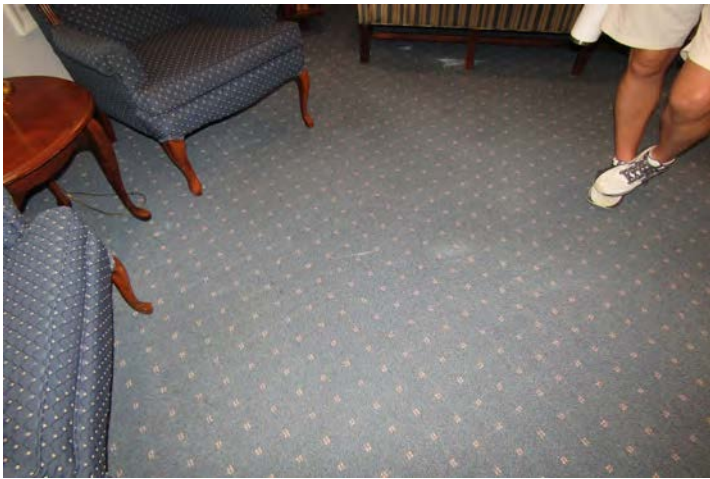
Small stains visible on the carpet

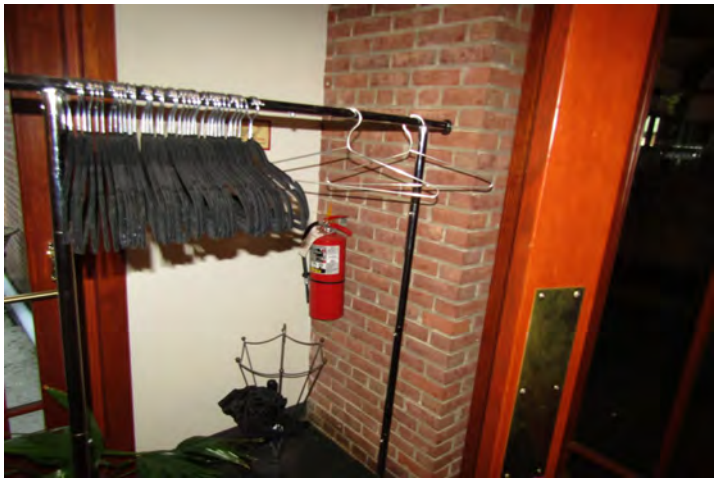
Blocked access to the fire extinguisher and door

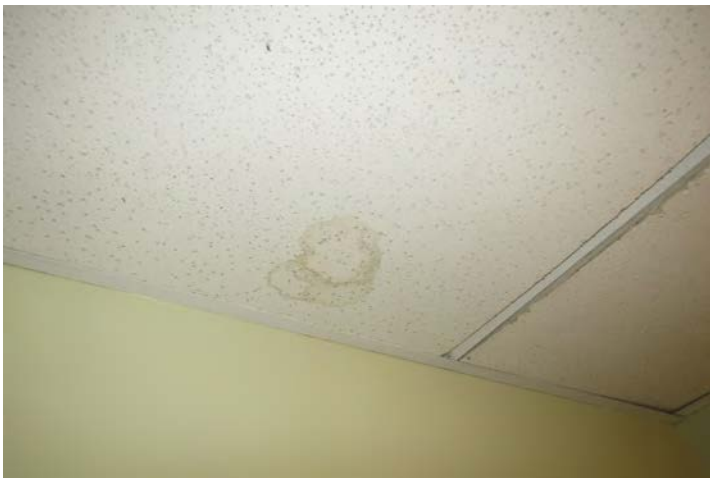
Stained ceiling tile

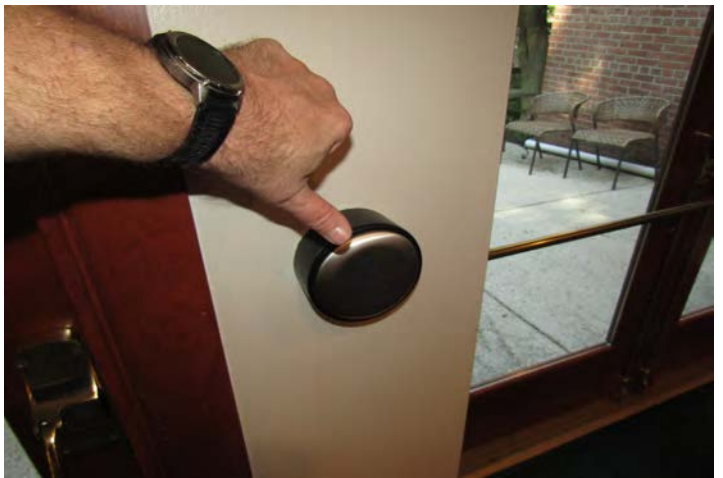
Opener does not unlock the door

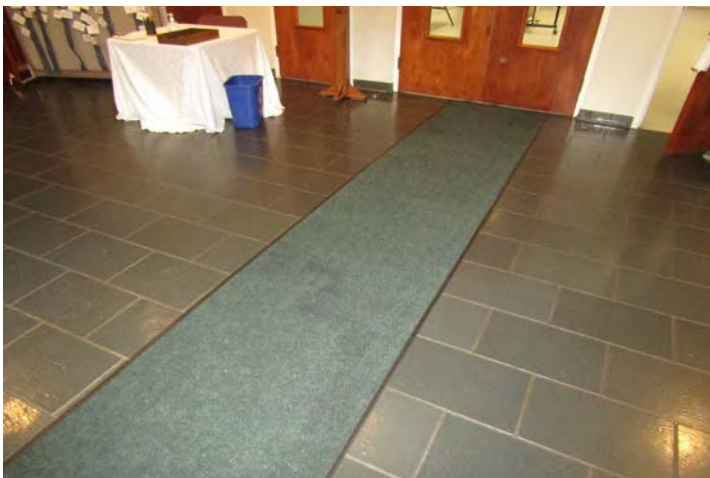
Entrance matting is worn and too narrow

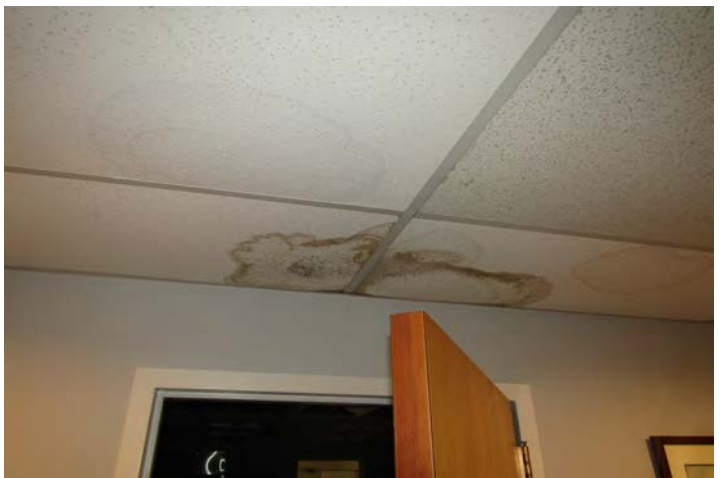
Stained ceiling tiles

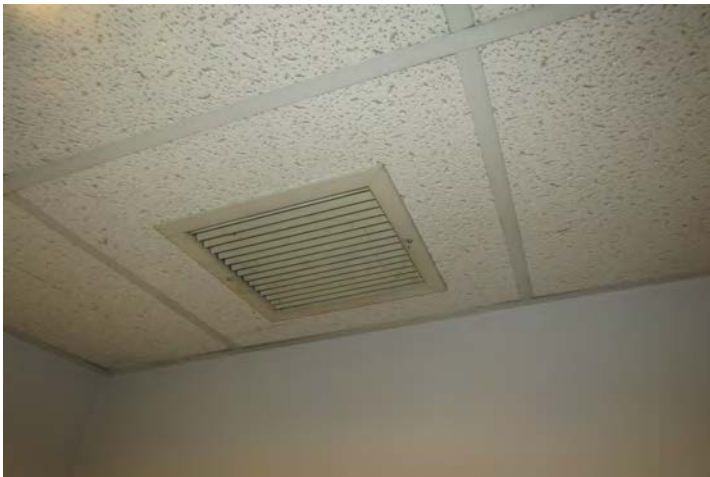
Debris buildup on the exhaust vent

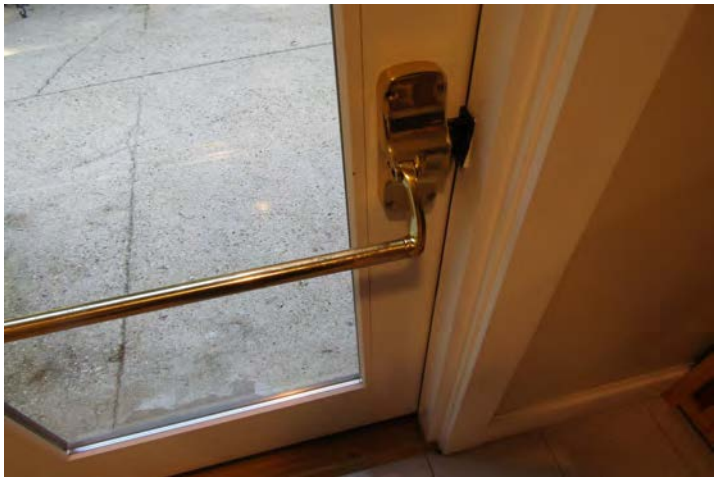
The finish is wearing on the pushbar

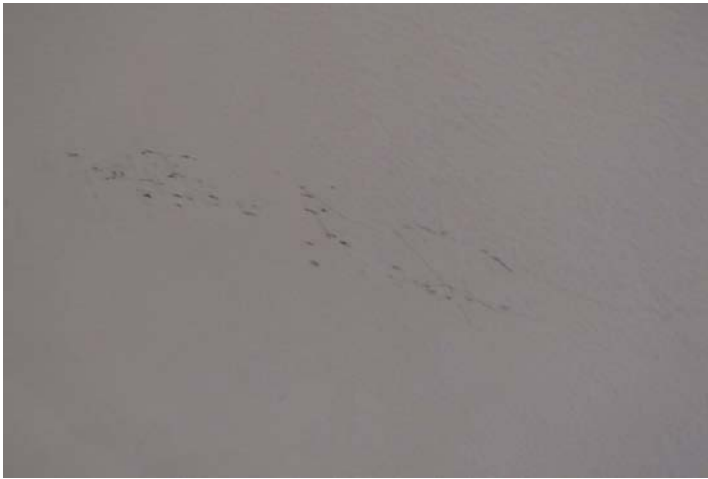
Wall damage

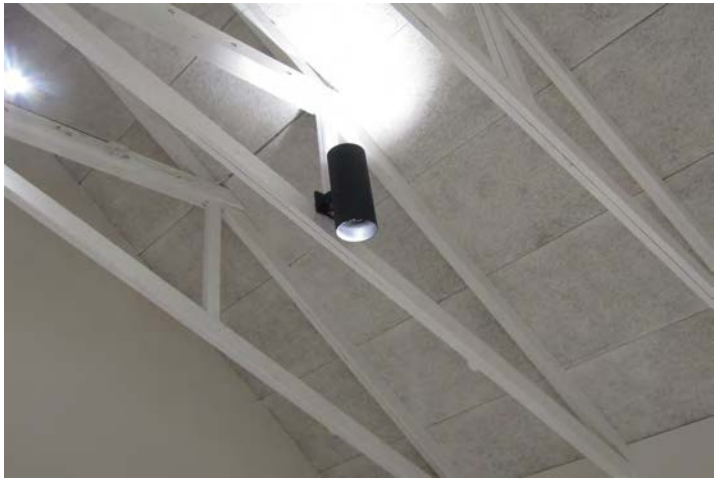
Cobwebs and debris on the light and framing

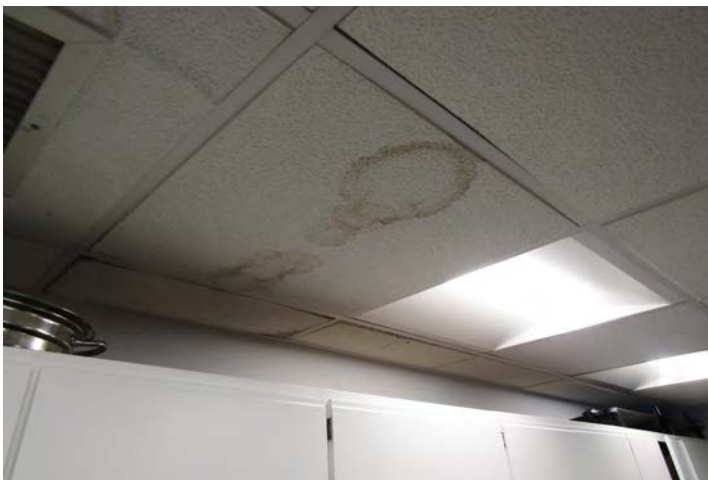
Stained ceiling tiles

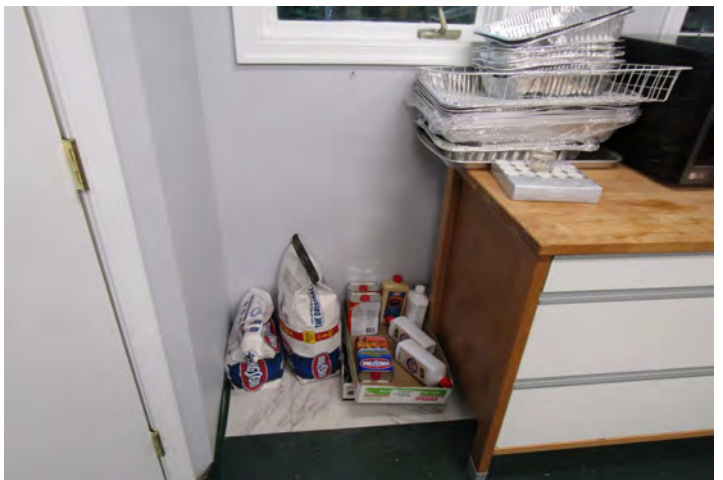
Flammable liquid left unsecured

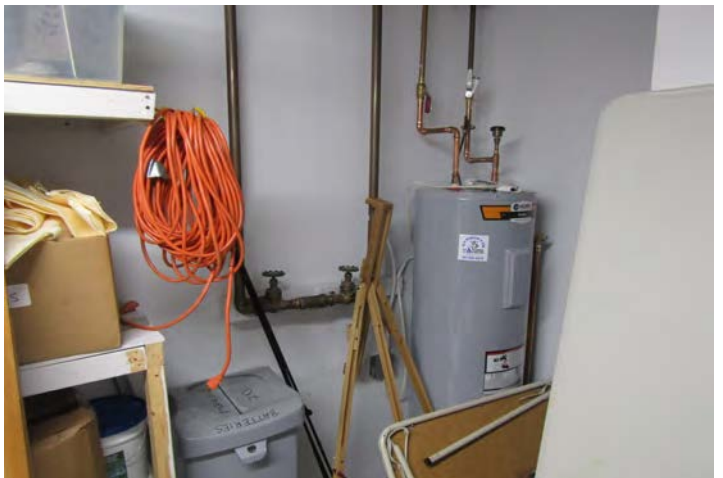
Blocked access to the hot water heater

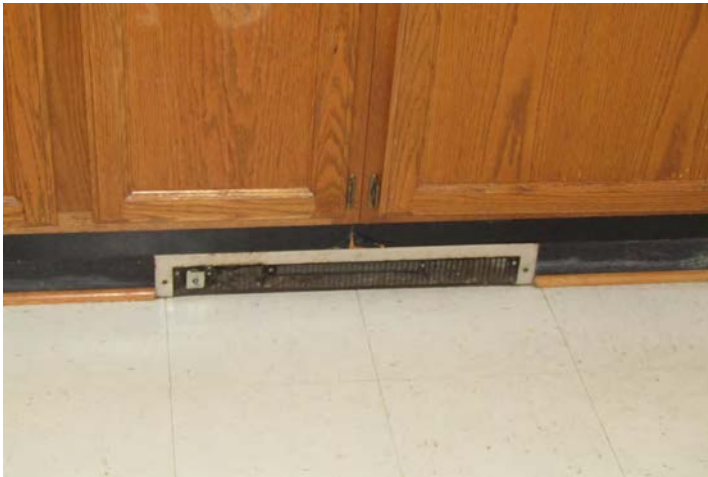
Debris buildup on the floor base

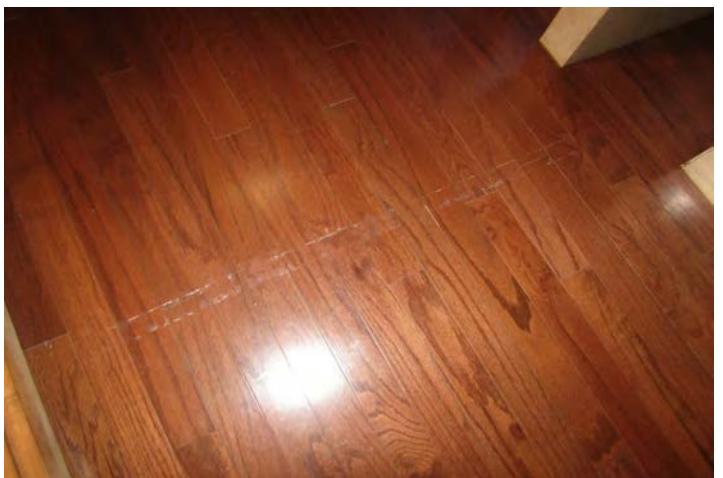
Minor floor damage

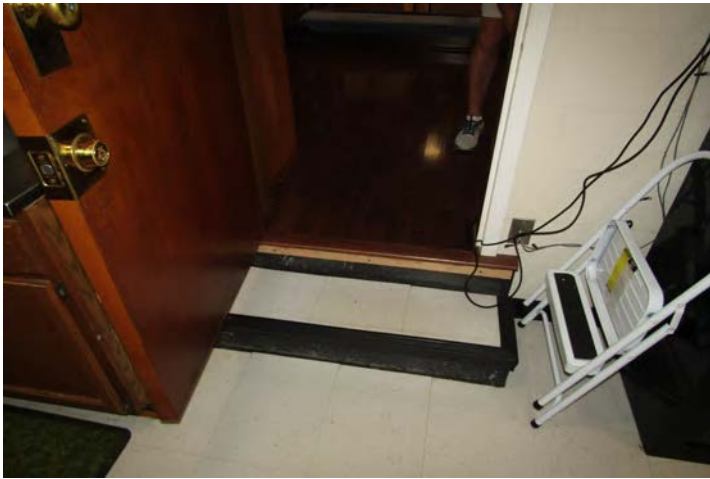
Access to sacristy needs a railing

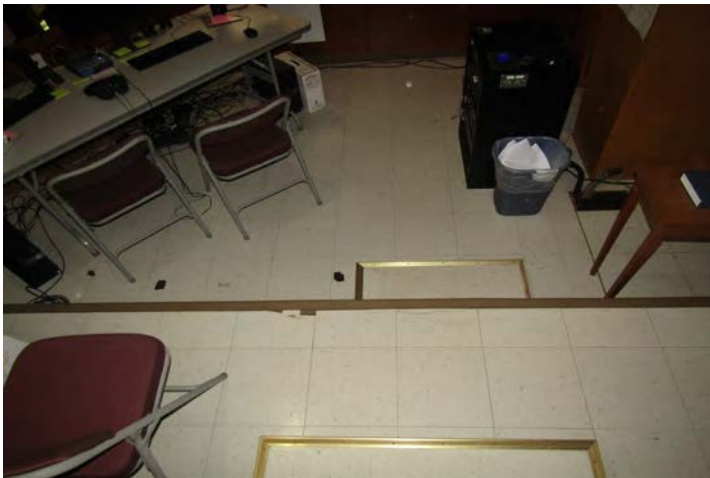
Potential trip and fall hazard

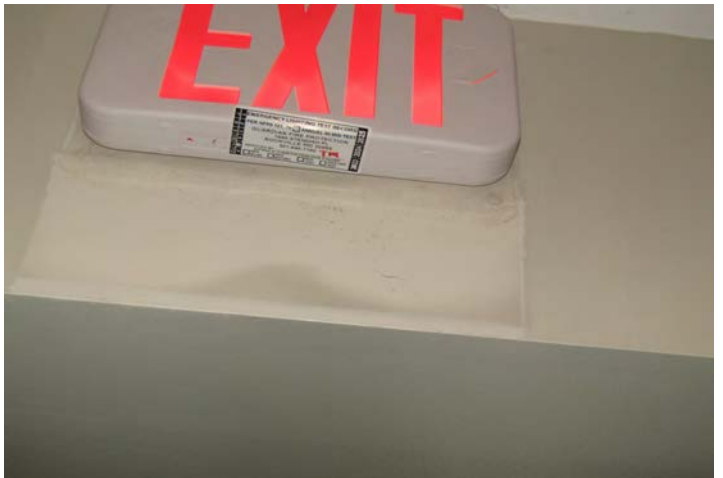
Wall touchup needed

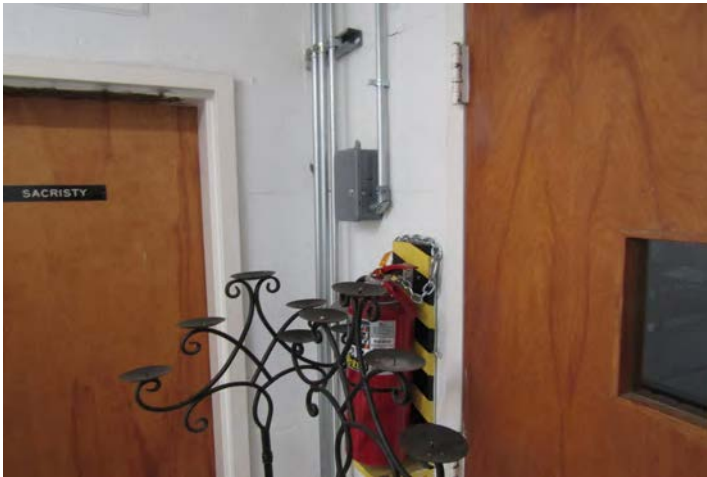
Blocked access to a fire extinguisher

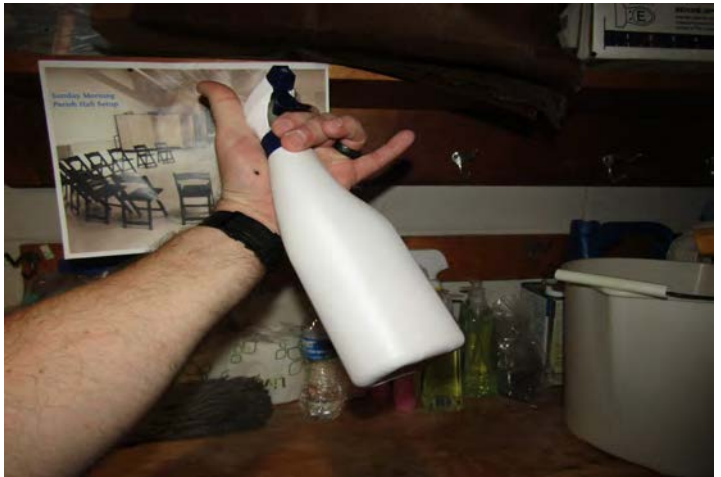
Improperly labeled secondary chemical container

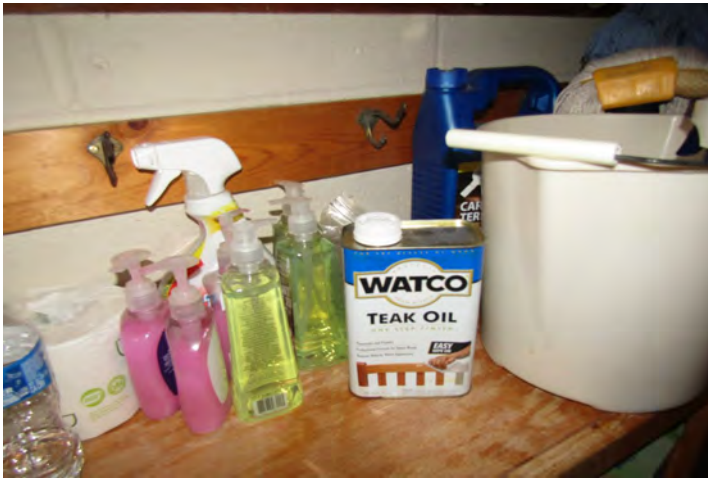
Cleaning and maintenance supplies co-mingled

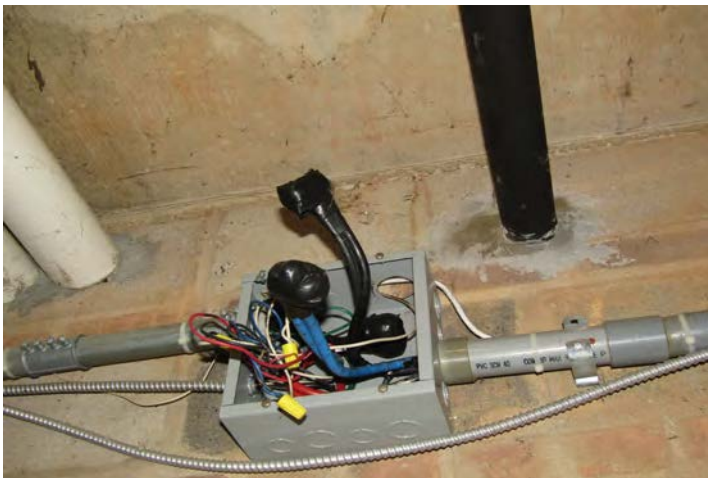
Improper electrical connection, missing junction box cover

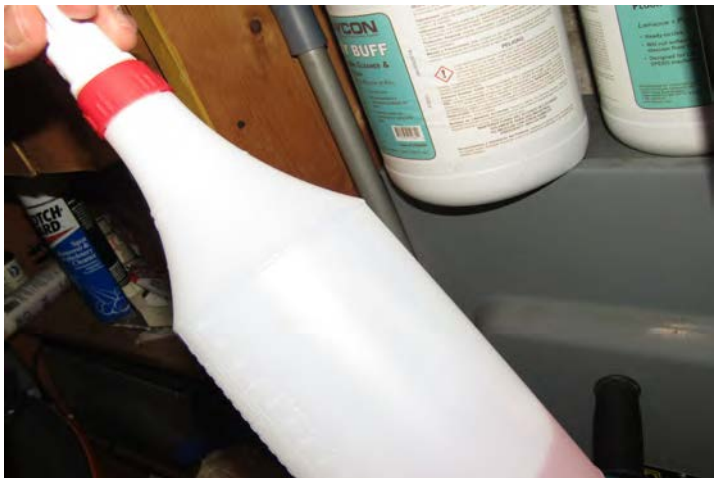
Improper label for secondary chemical container

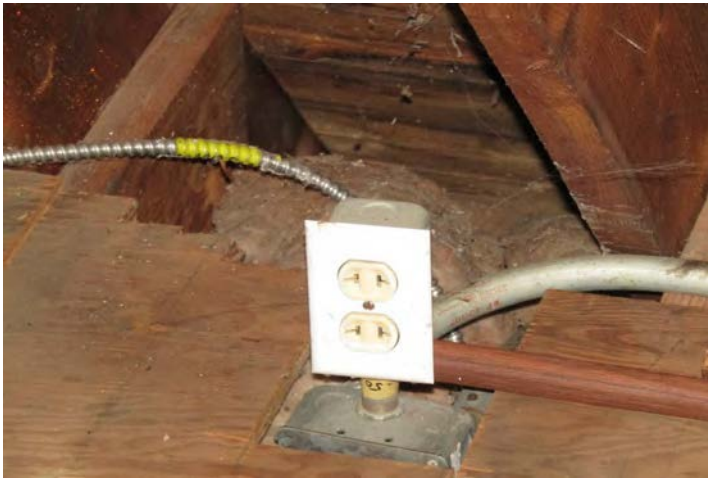
Ungrounded outlet, incorrect junction box for a floor mount

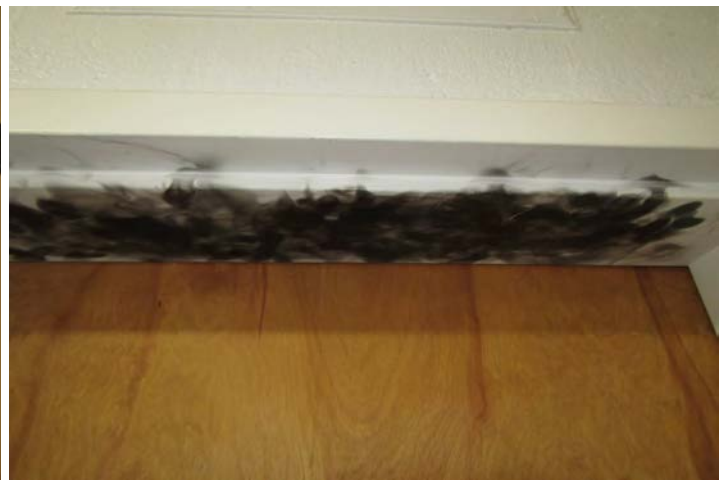
Burn marks on the door frame header
