# **I FACILITY CONDITION ASSESSMENT**

## **St. Dunstan's Episcopal Church**

Bethesda, MD

July 2024

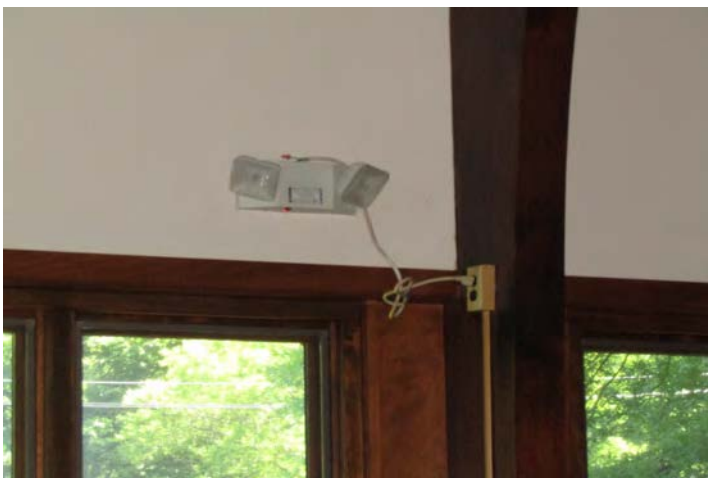
Incorrectly wired emergency exit light

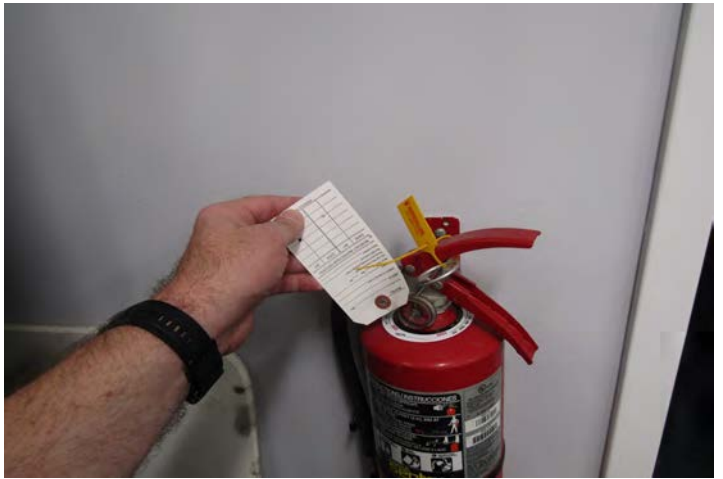
Monthly inspections are not noted

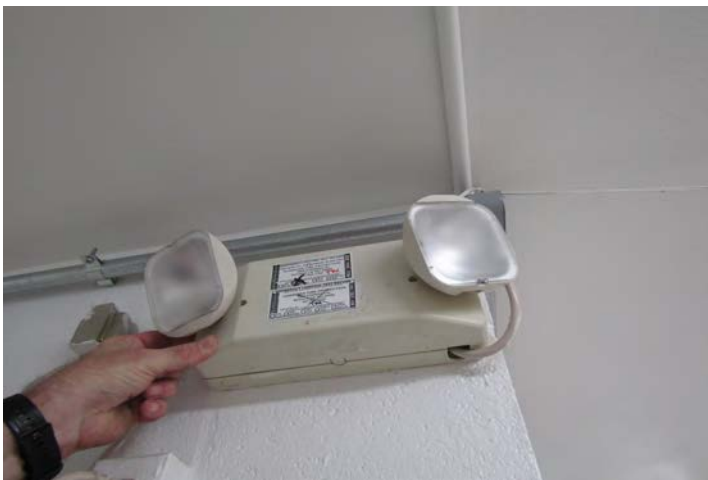
Emergency exit light did not function as designed

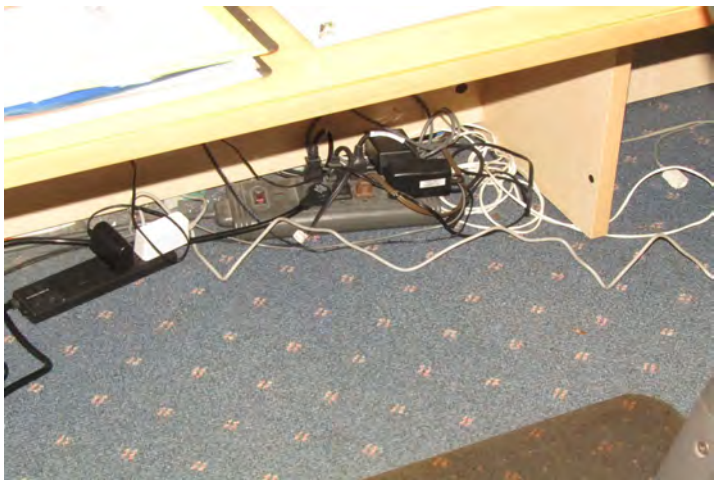
Unsafe cable management

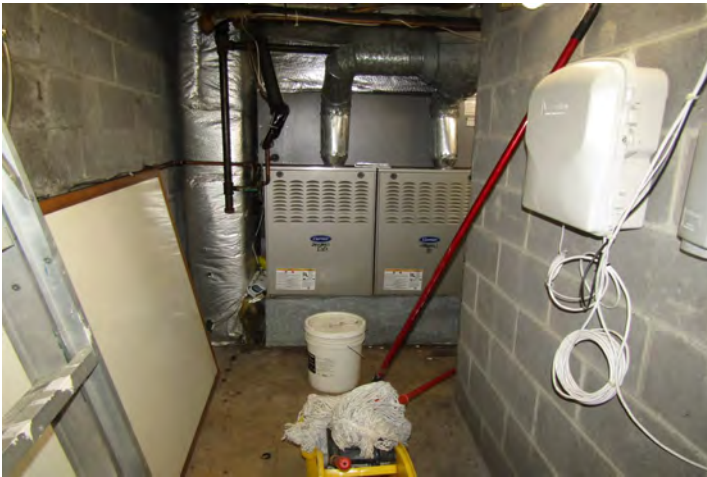
String mop used instead of microfiber
