# **I FACILITY CONDITION ASSESSMENT**

## **St. Dunstan's Episcopal Church**

Bethesda, MD

July 2024

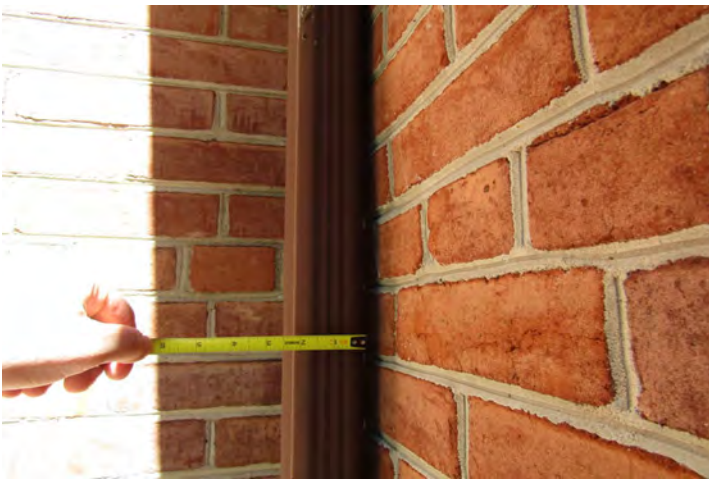
Downspout size is too small for volume

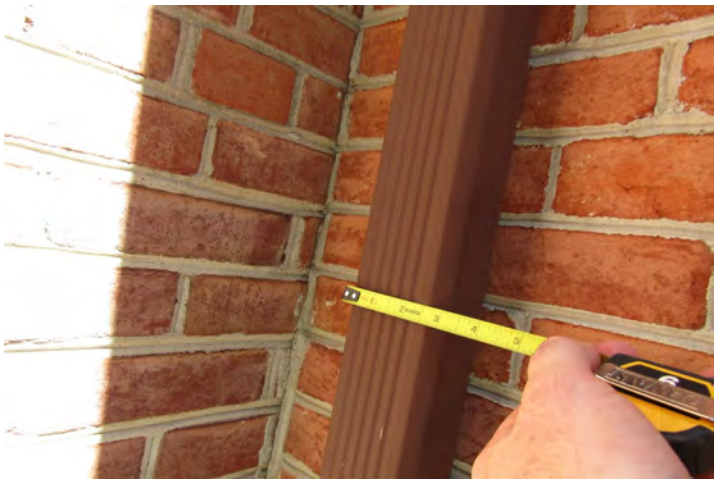
Downspout size is too small for volume

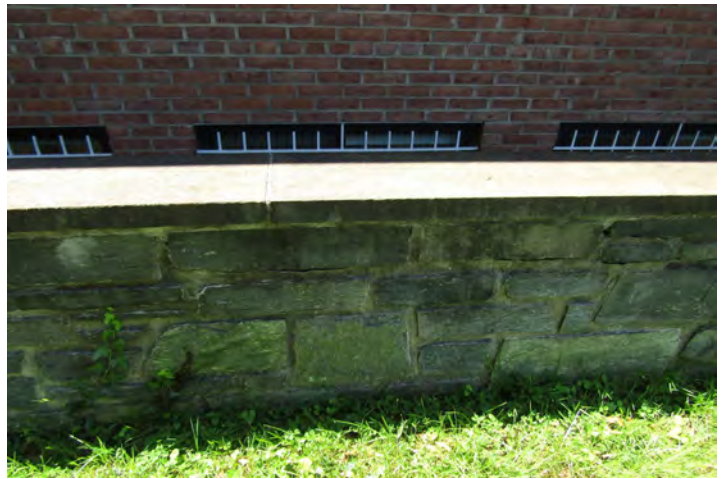
Masonry wall has shifted

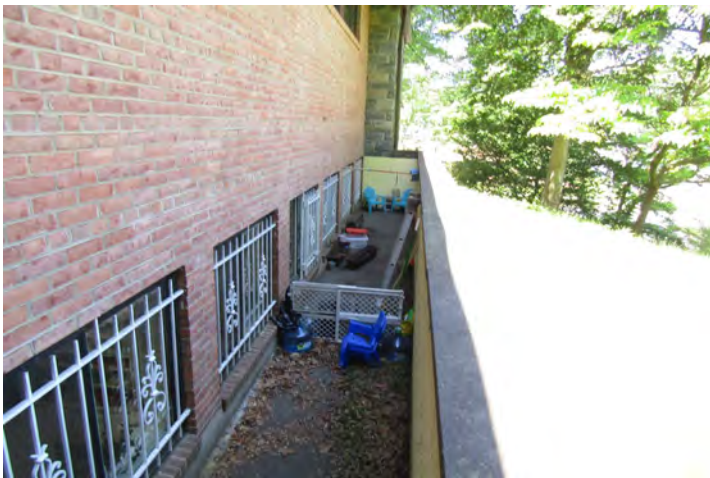
Debris buildup in the exit areas

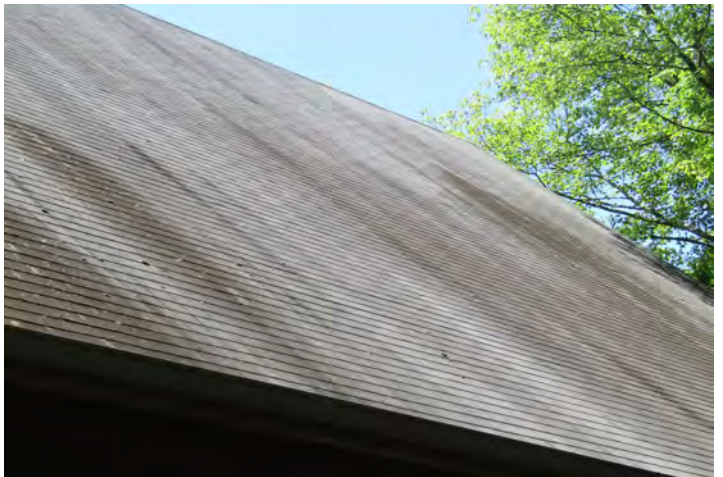
Shingles are past service life

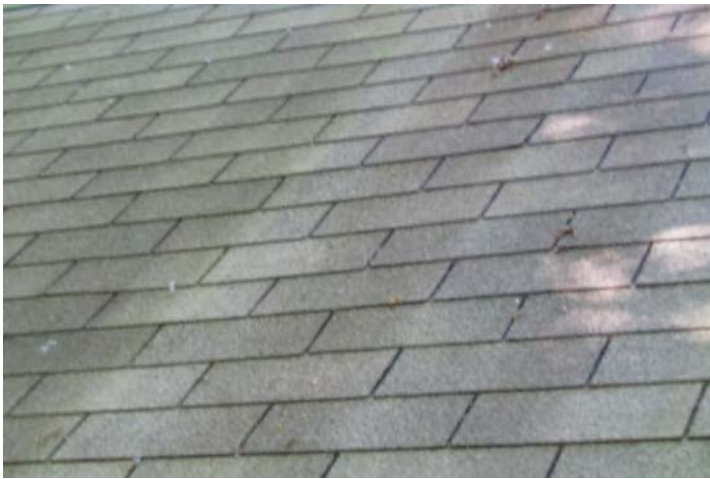
Shingles are past service life

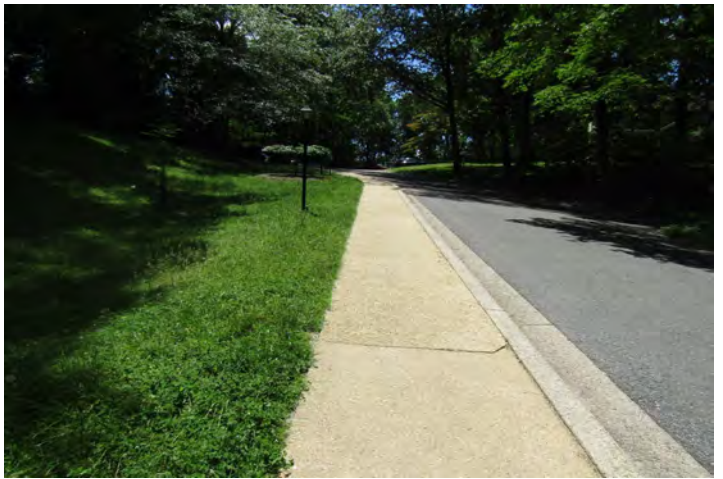
Sidewalk needs safety bollards and handrails

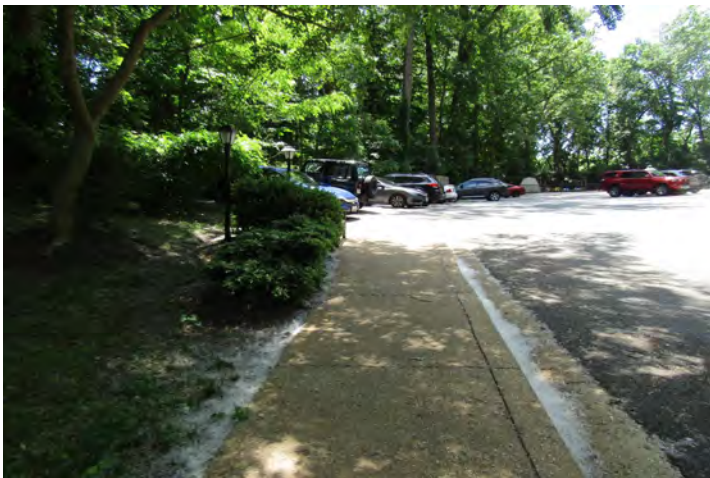
Sidewalk needs safety bollards and handrails

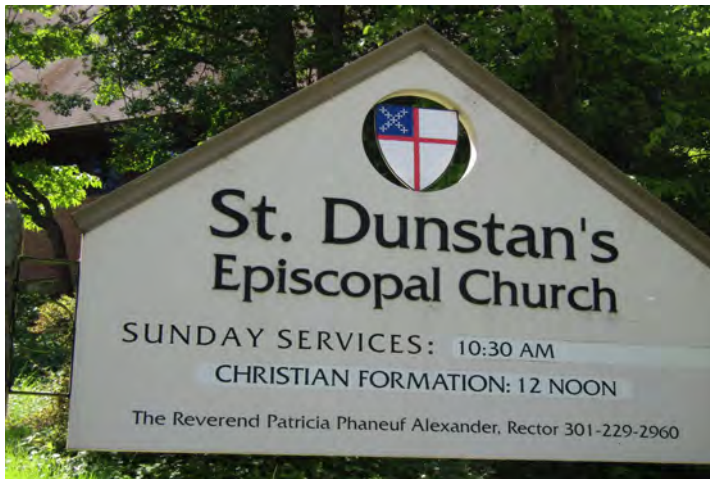
Monument sign needs repainting

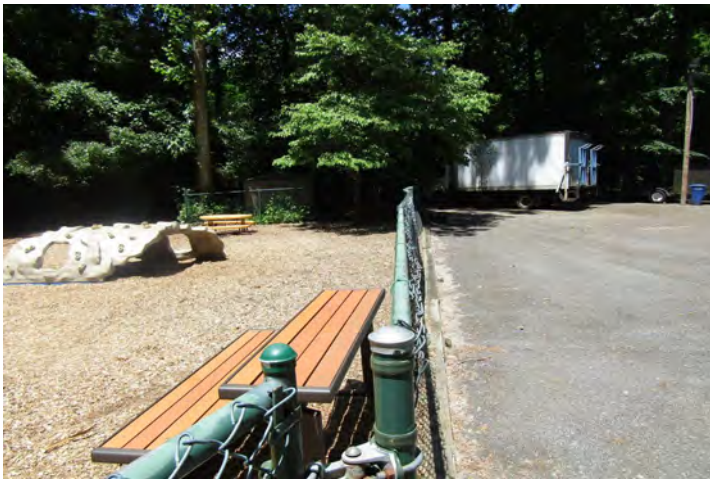
Playground fencing is crooked

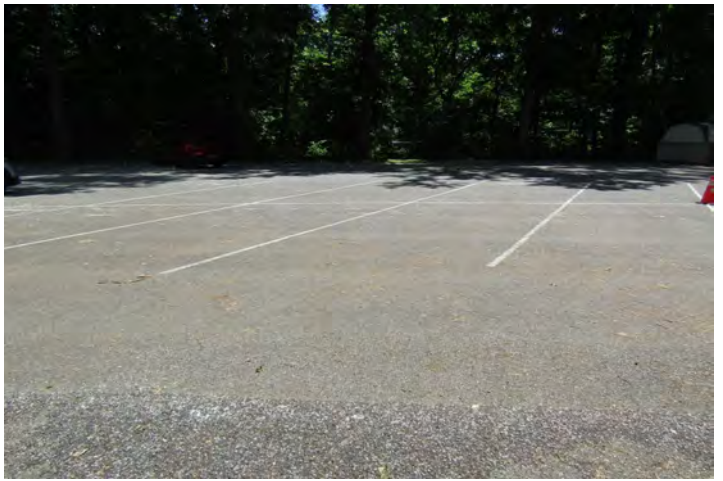
The parking lot seal and striping is faded

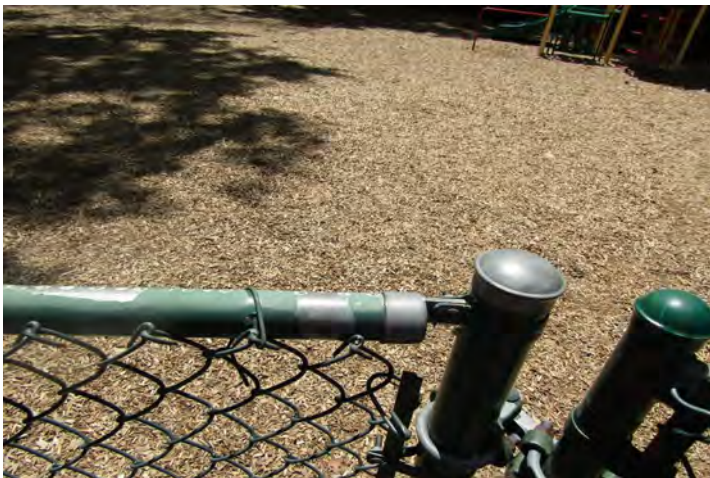
Chain-link fence paint is chipped

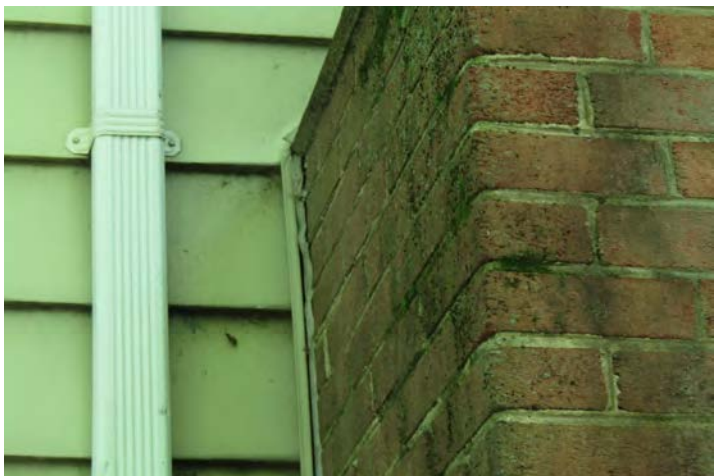
Organic buildup on the brick

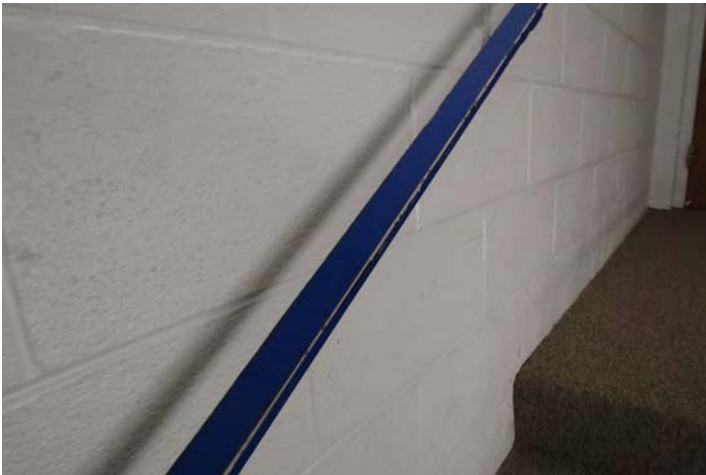
Chipped paint on the handrail

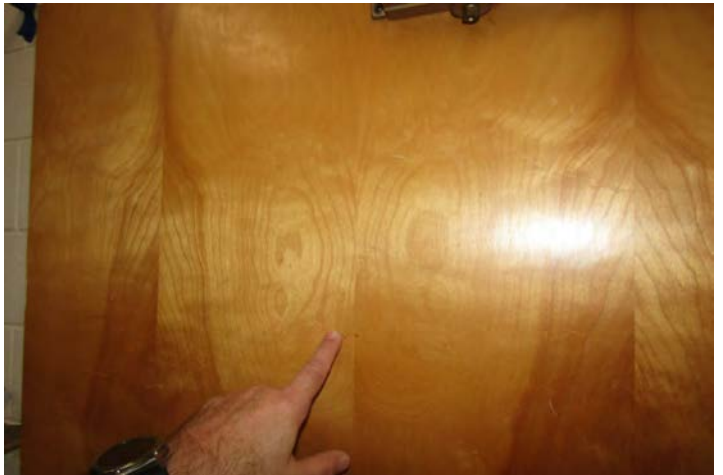
The door needs a door lite

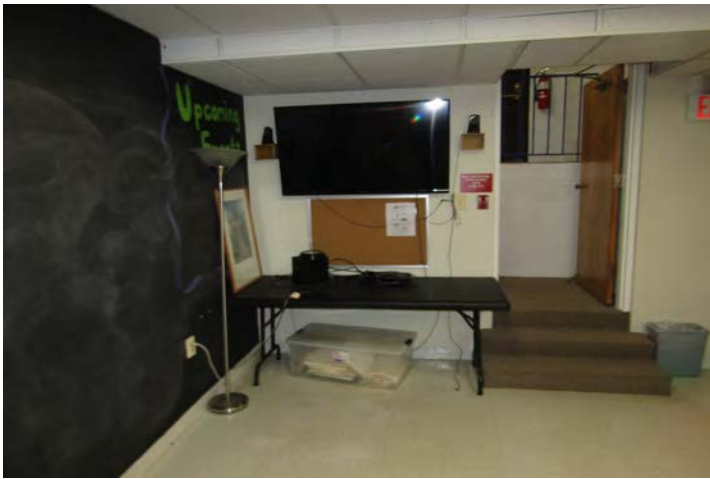
Access stairs need a handrail

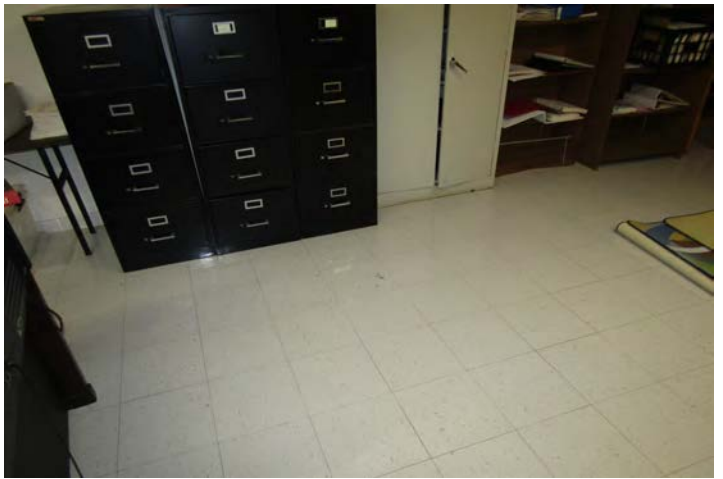
VCT floor needs a strip and re-wax

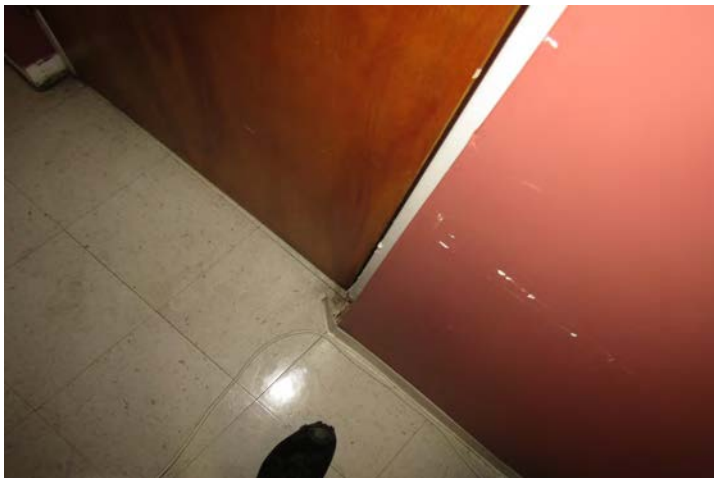
Chipped paint on the wall

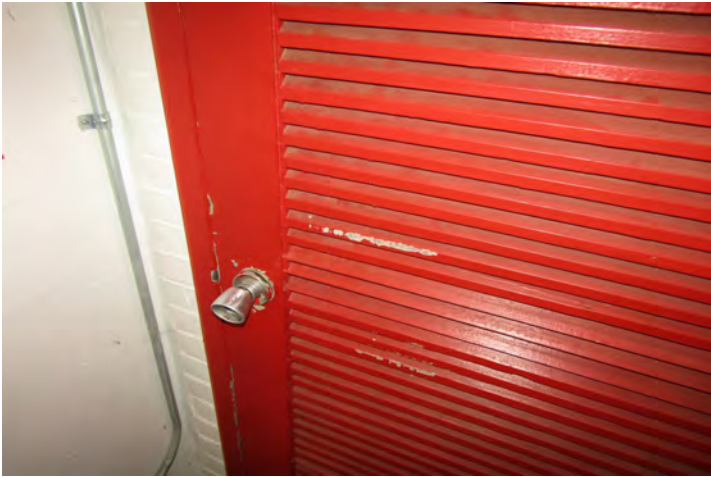
Chipped paint on the door

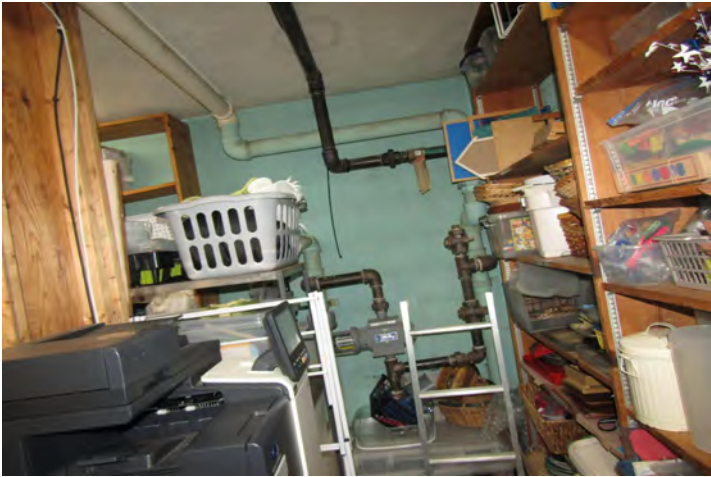
Gas main access is blocked

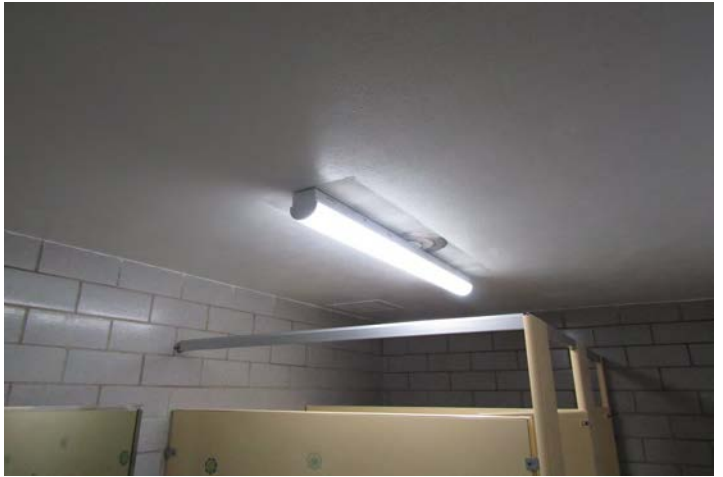
Ceiling touchup needed around the new light

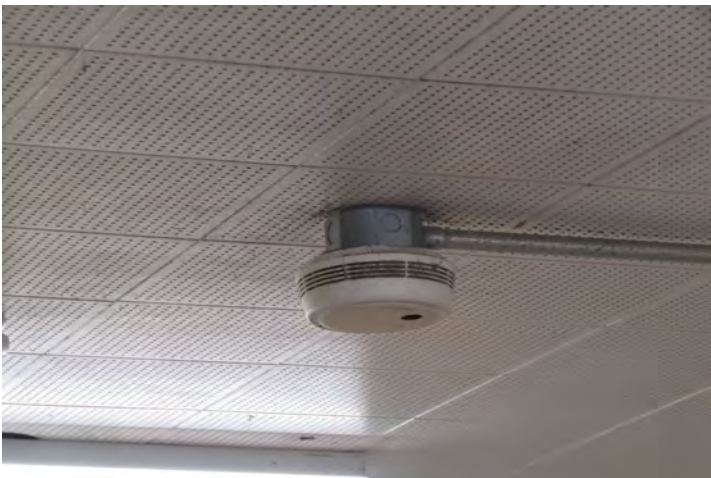
Debris buildup on the sensor

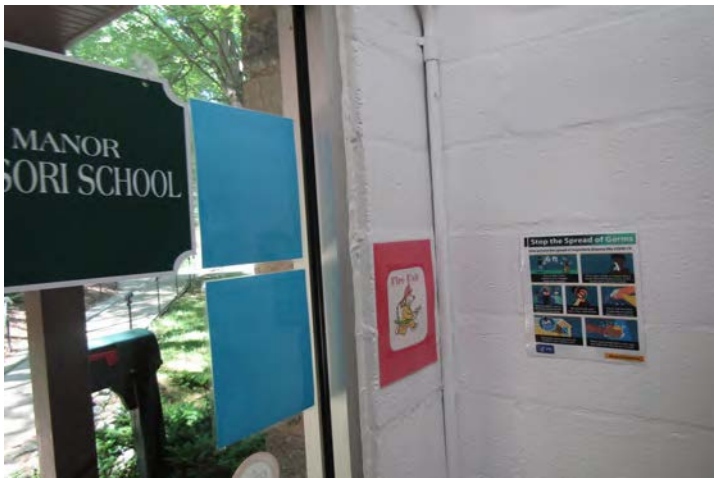
Debris buildup in the corner

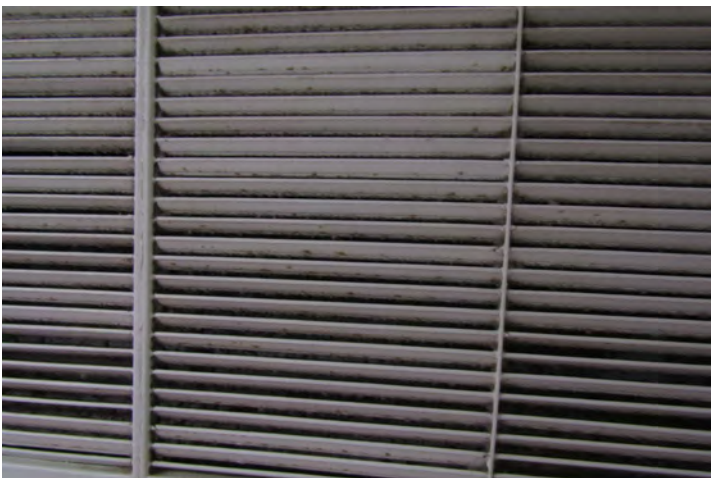
Debris buildup on the vent

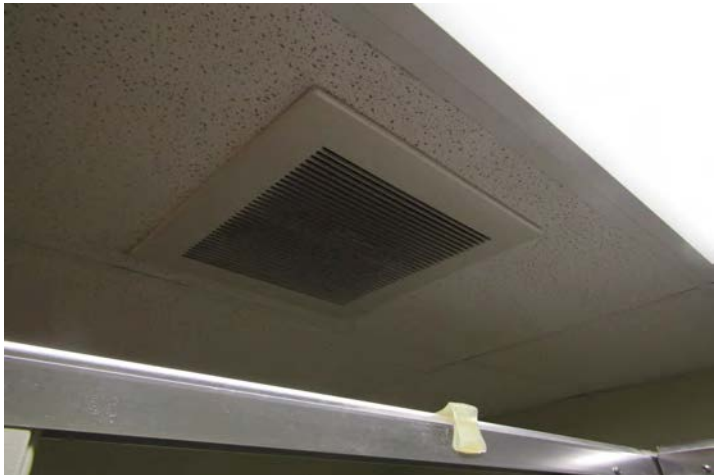
Debris buildup on the exhaust fan

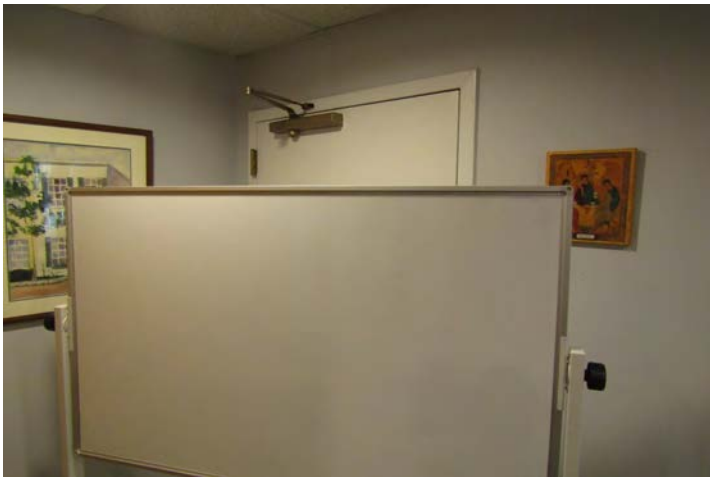
Egress door is blocked

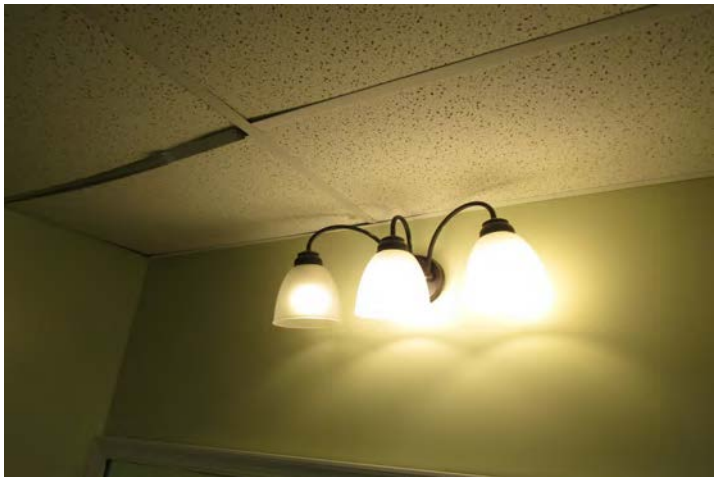
Ceiling tiles out of place

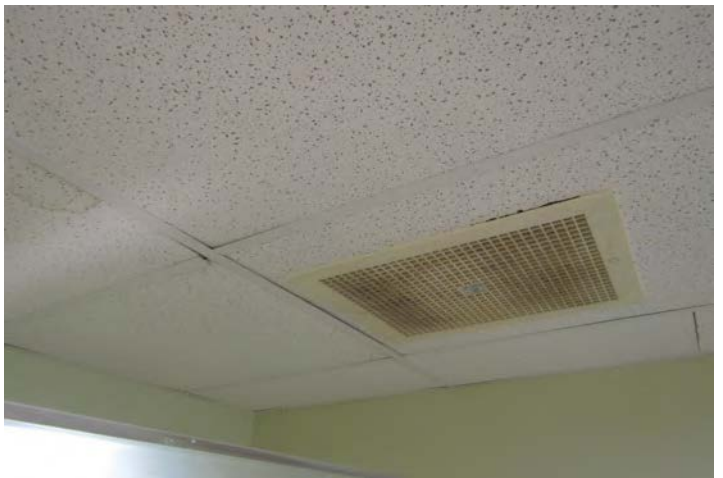
Debris buildup on the exhaust vent

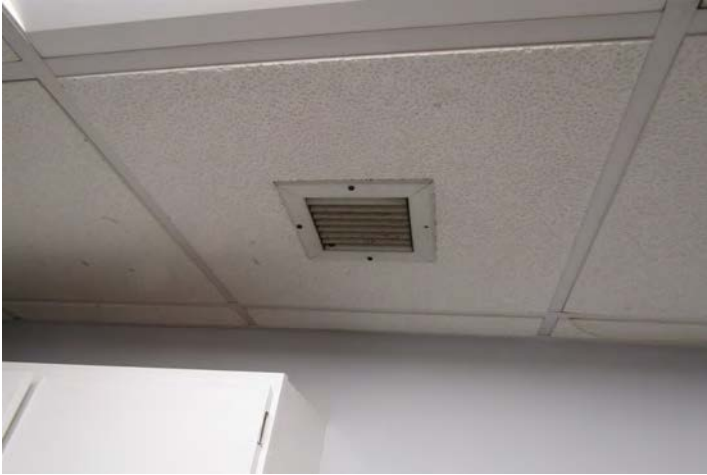
Debris buildup on the exhaust vent

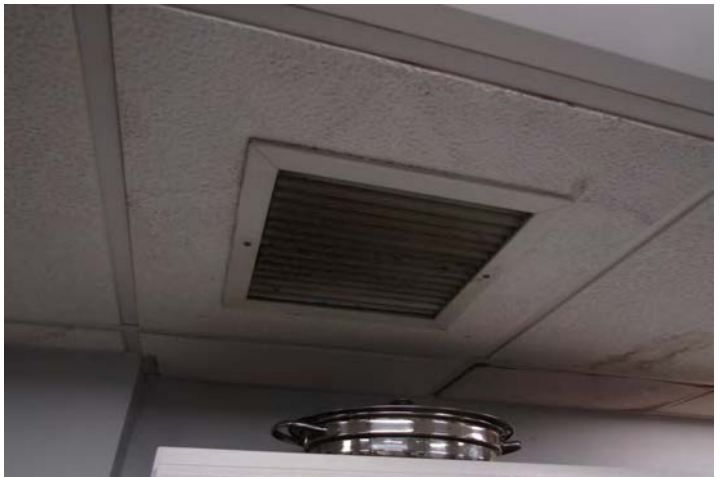
Debris buildup on the exhaust vent

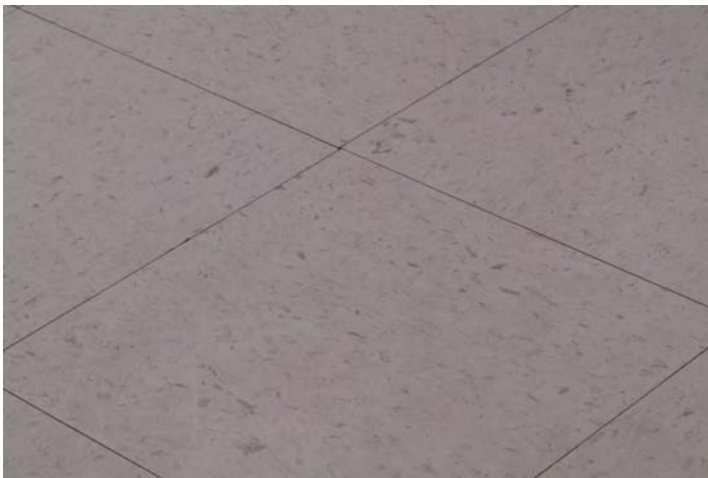
**Parish Hall and Kitchen** – The Parish Hall was in acceptable condition. Dust and debris are visible in the upper areas of the space and in the lights. The VCT floor was in poor condition. A strip and recoat would revive the surface and improve the look. It is great to see that the attic access ladder in the area was the better-quality aluminum ladder style. This more robust design is safer for all who may need to climb it. Some items blocked access to the water heater and should have been stored in a different area. As with electrical panels and equipment cut-offs, you should have 36" of clear space around the water heaters when possible. The kitchen was in acceptable condition. There were stained ceiling tiles that needed replacing. The flammable items stored loose in the kitchen (lighter fluid) should be in a secured, preferably fire-resistant, cabinet or stored in an exterior building. We recommend adding a peephole to the exterior egress door. Significant dust and debris buildup was visible on the vents in the ceiling.

The VCT needs a strip and re-wax

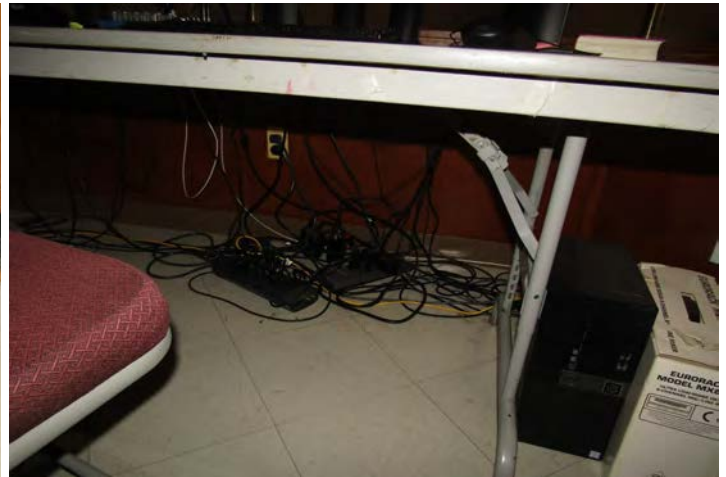
Cable management is poor

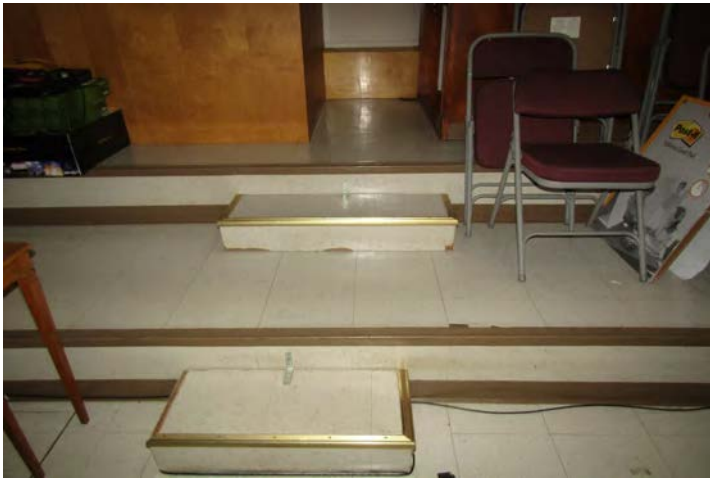
Steps need a handrail

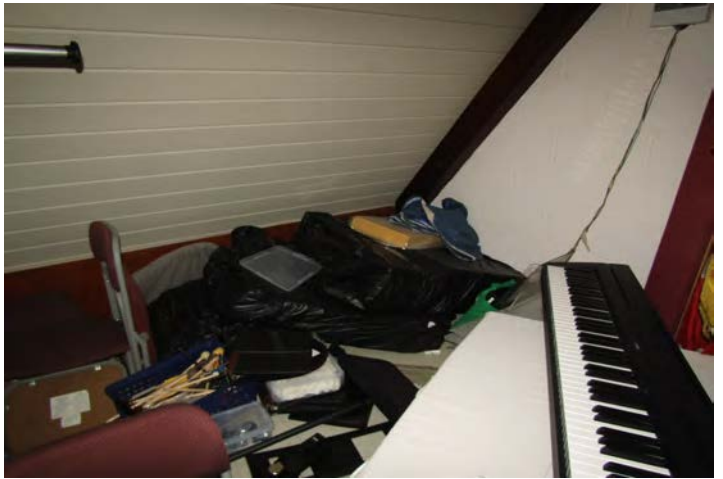
Excess of of items stored

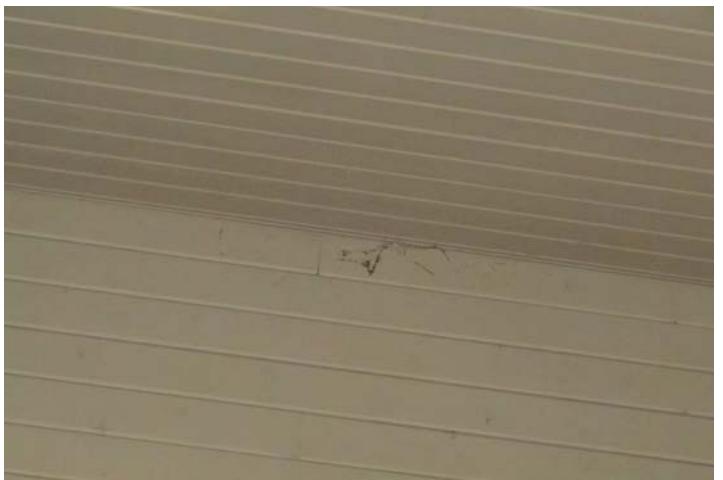
Debris buildup in the high spots

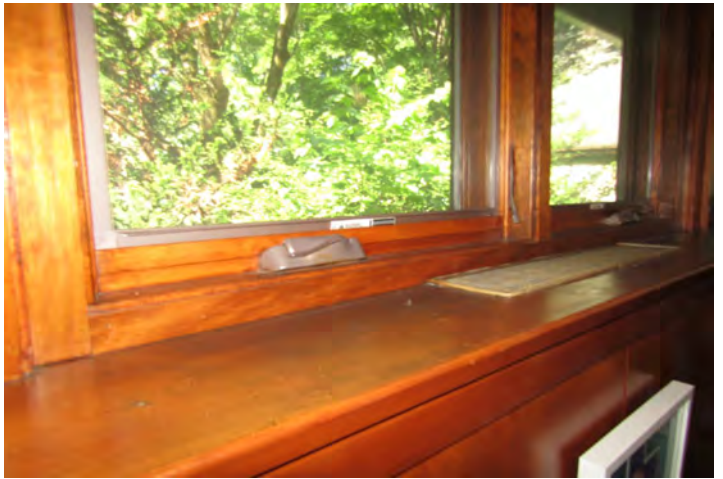
**Sanctuary** – The Sanctuary is in good condition. The wood trim around the windows exhibits the most significant deterioration in the space due to the constant temperature fluctuation. Cleaning the window trim with a citrus-based cleaner/degreaser and then adding a wood protectant that adds wood oil back into the wood would be helpful to prolong the material. Sealing the material with any polyurethane or shellac would cause significant issues in the long term. It is best to allow the material the ability to “breathe”. The balcony is no longer set for occupation other than for the tech teams. We recommend purging the balcony of all the unnecessary items and adding storage racking and shelves for what remains. In its current condition, it is a life-safety and fire-load concern. In the Narthex, several items appear to be unnecessary or stored haphazardly. Purging all unnecessary items and organizing what is left will help the visual appeal of the space and make it more practical. Adding racking, shelving, or even cabinets is recommended. The steps from the Altar into the Sacristy are a small safety concern. We recommend adding a visual marker at the step edge (on the Altar side) as well as considering an additional handrail.

Wood needs cleaned and refreshed

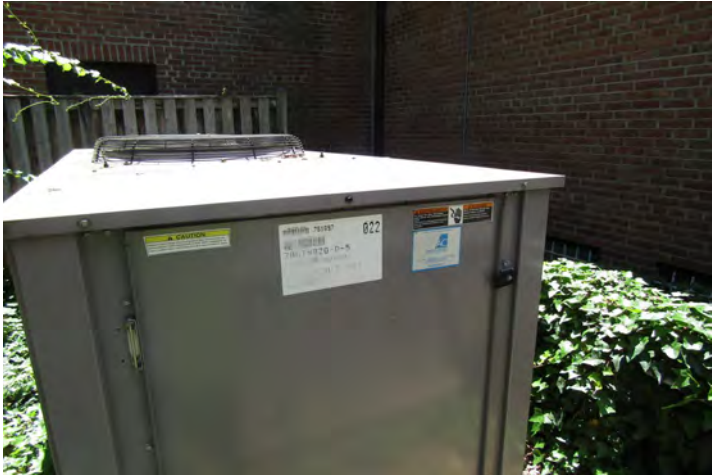
Your current chiller is at the end of its expected service life. While it is still working, we encourage you to develop a plan to change it and set aside the funds to accomplish it. Current wait times for equipment like your chiller can exceed nine months. We also recommend keeping the organic growth culled back from the equipment (within the mechanical yard fencing). We encourage you to create and maintain 36" clear access space to the items in the mechanical rooms and by area with equipment or electrical panels.

Chiller which shows landscaping being too close

| St. Dunstan's Episcopal Church | | | | | |
|---|---|---|---|---|---|
| HVAC | Carrier Chiller 2102F55999 | Exterior | \$90,000 | Immediately | The Carrier chiller is past its expected service life. While it may still function, the plans to replace it should be in place, along with the funds. Time for delivery for these units can exceed 6-9 months. |

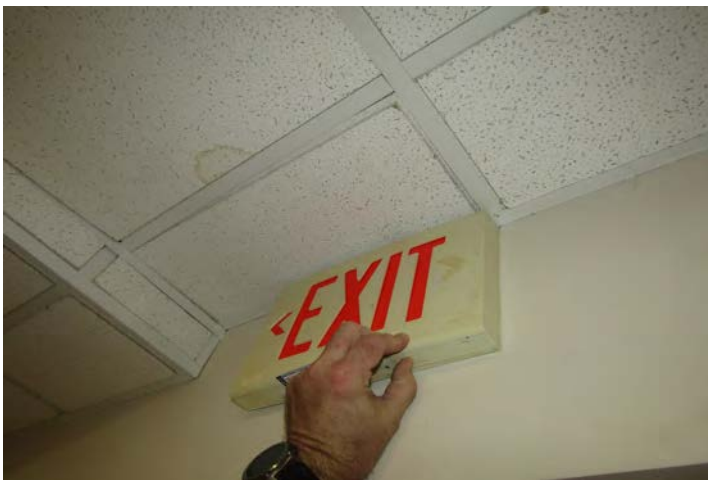
Emergency exit sign did not function as designed

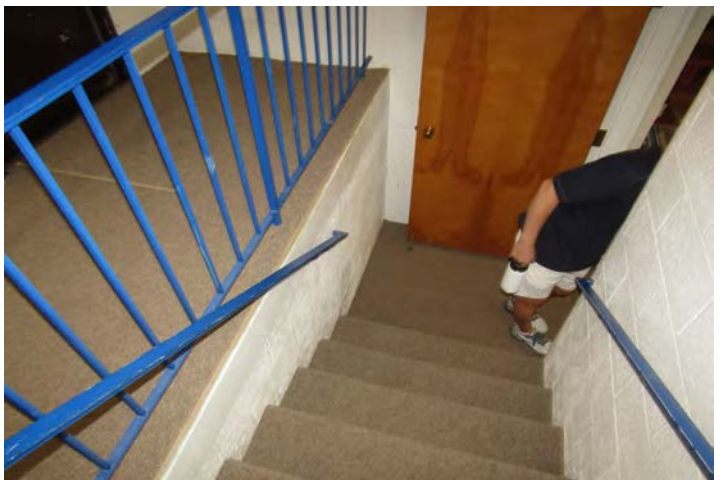
Musty smell indicates potential mildew in the stairwell

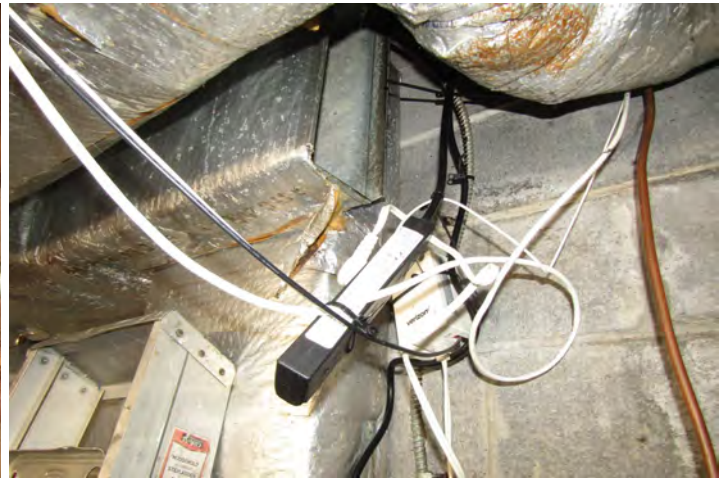
Suspended power strips and extension cords instead of proper circuits

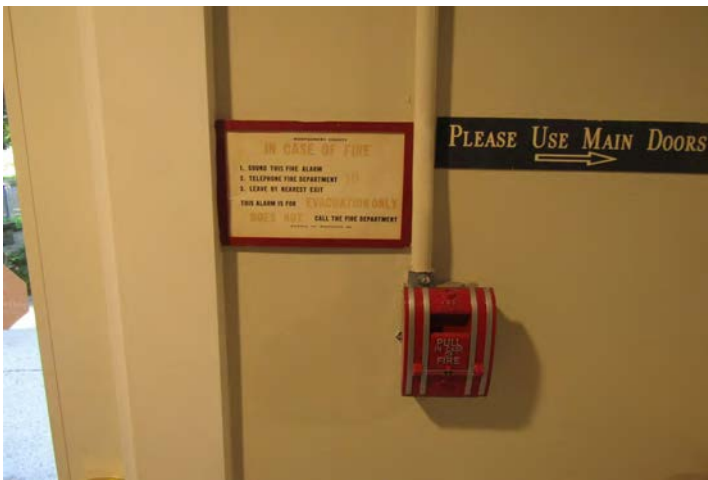
Unmonitored fire alarm

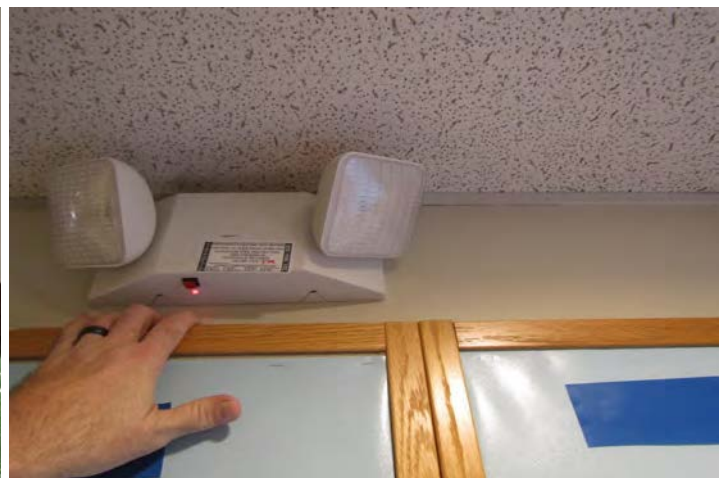
Emergency exit light did not function as designed
