# **I FACILITY CONDITION ASSESSMENT**

## **St. Dunstan's Episcopal Church**

Bethesda, MD

July 2024

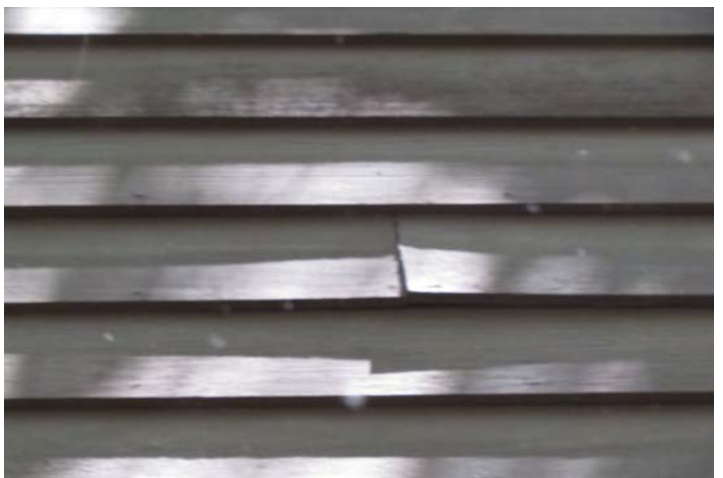
Warped siding

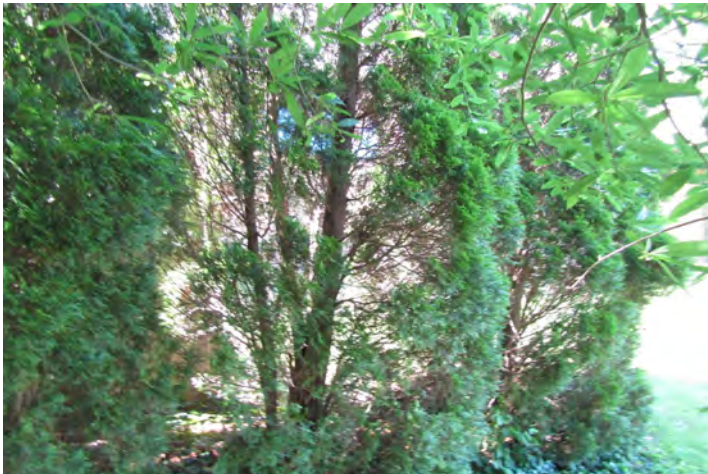
Many of the trees need thinned and trimmed

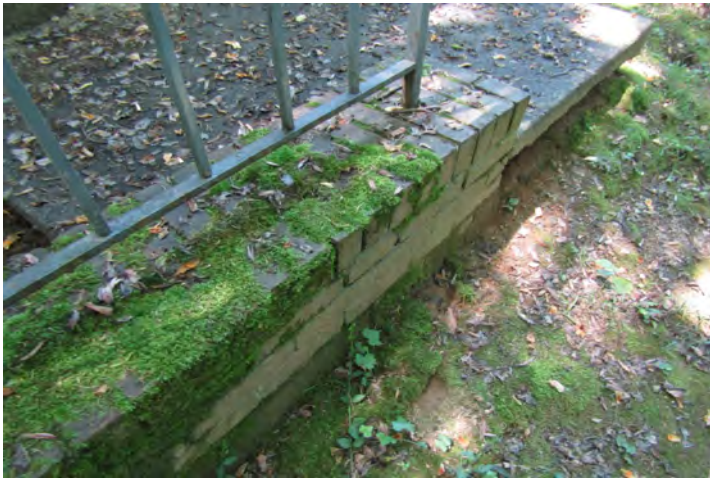
Egress path is slippery

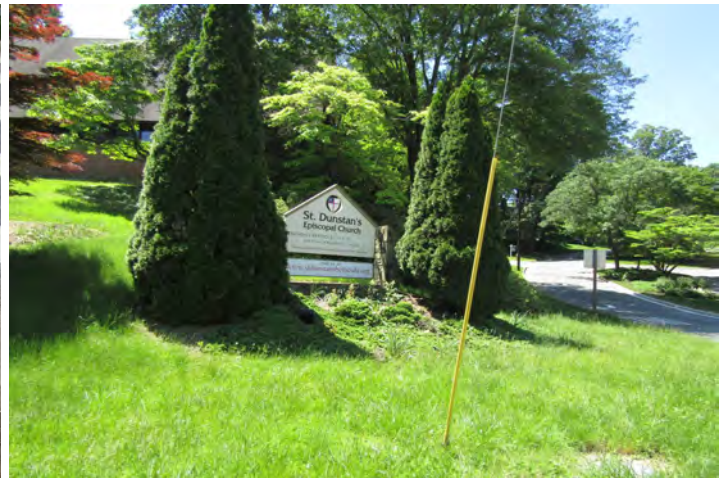
Landscaping has overgrown the facility

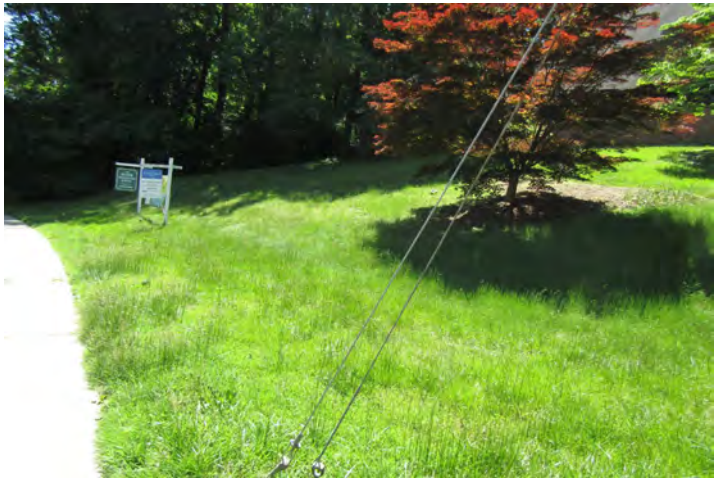
The large hill could be terraced

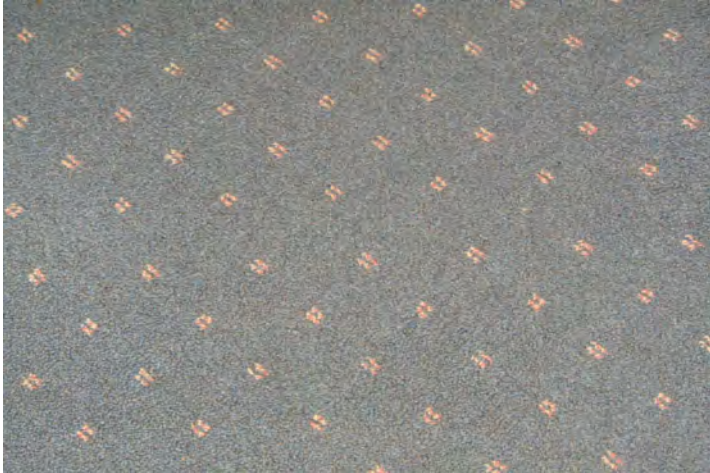
Small stains visible in the carpet

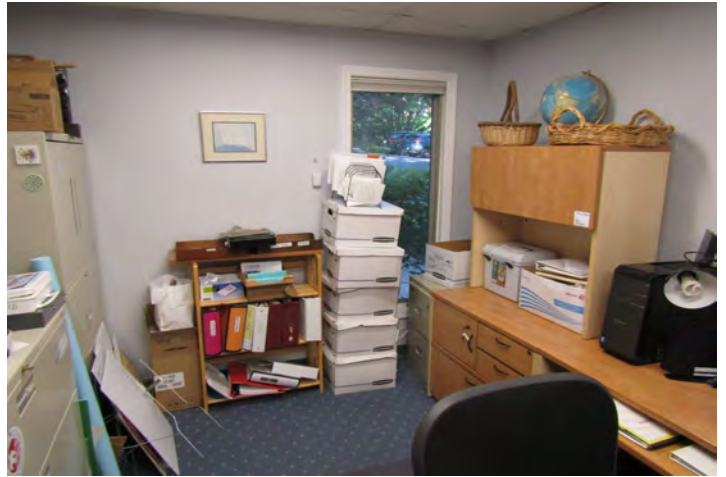
Spaces need more storage capability

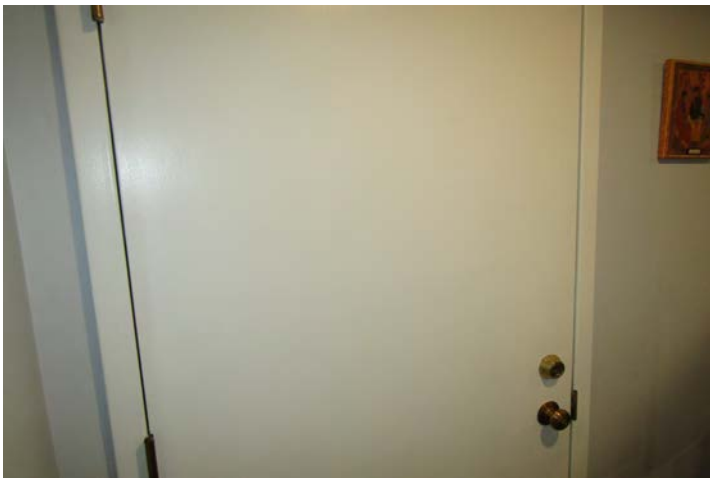
The door needs a peephole

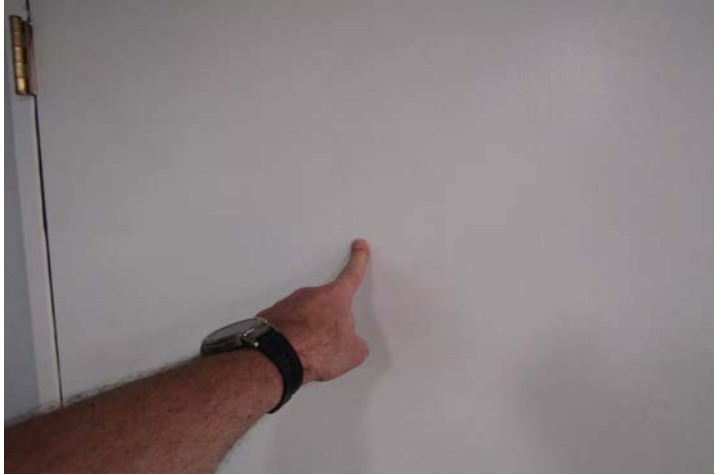
The door needs a peephole

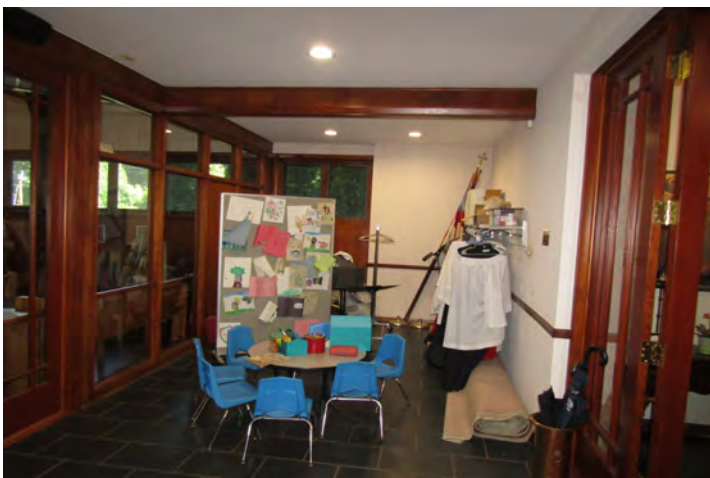
Excess of items stored

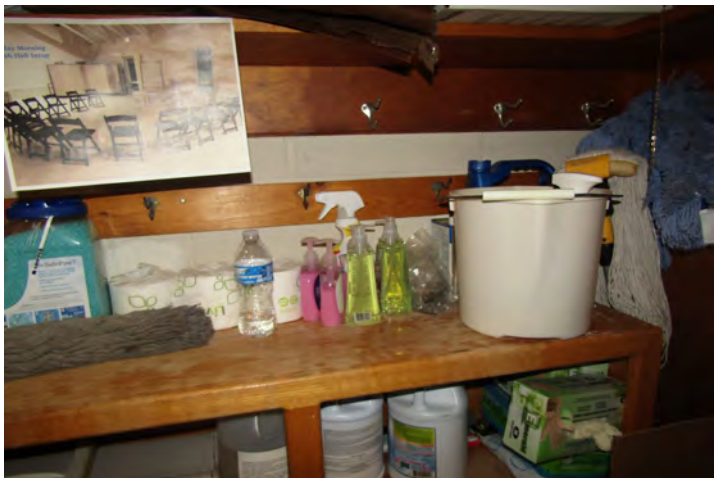
Poor organization of items

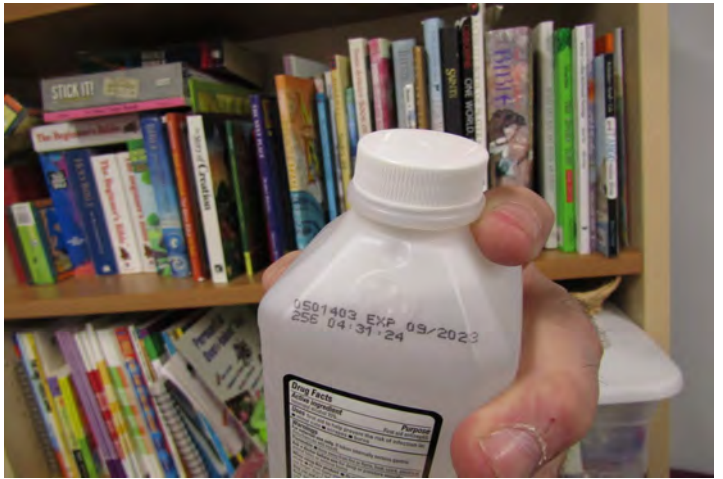
Expired 1st-aid items

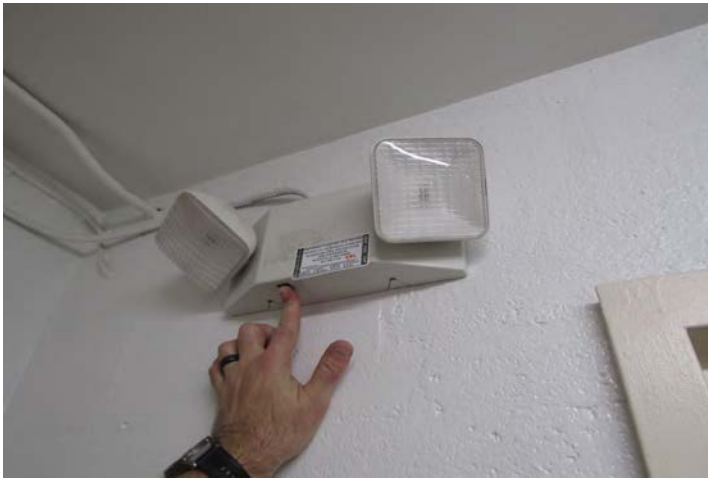
Emergency exit light did not function as designed

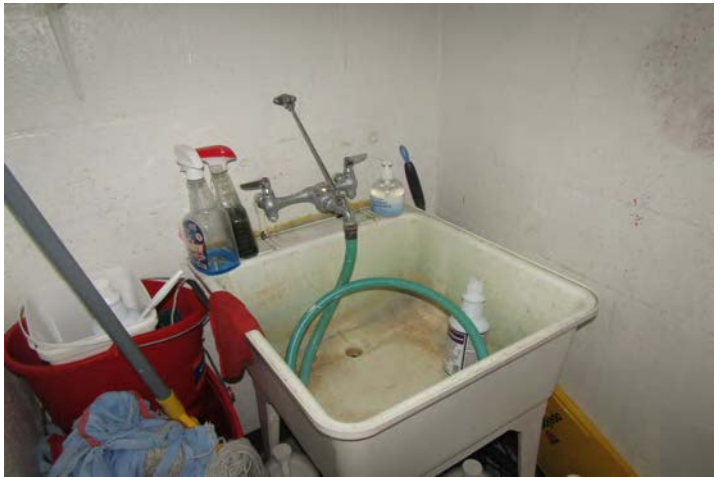
Dirty tools and equipment

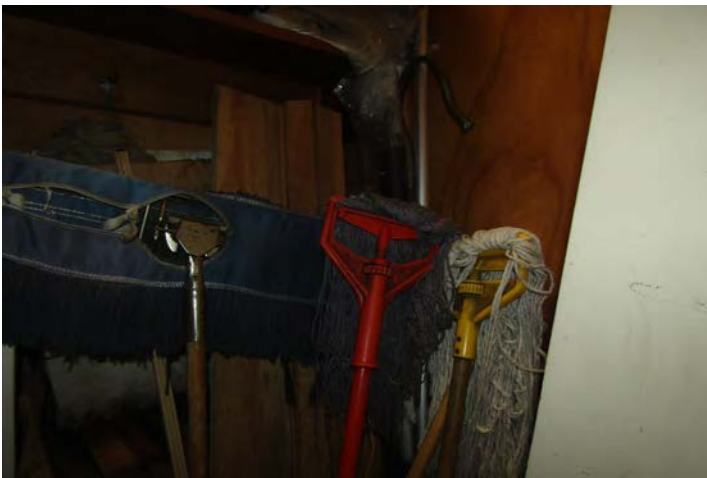
Dirty equipment

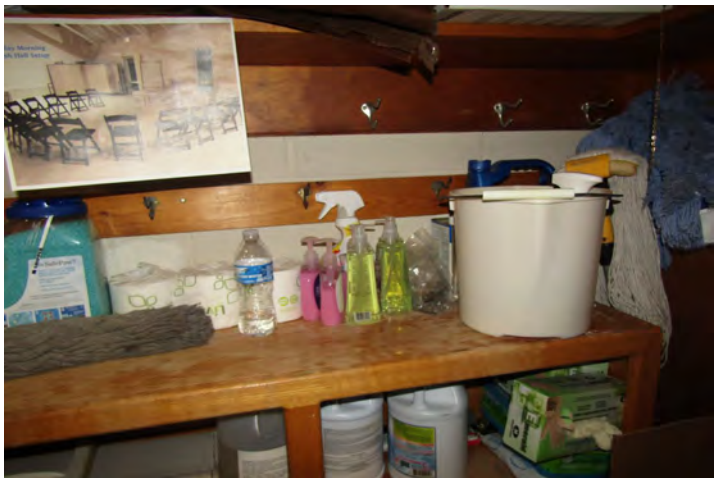
Random chemical selection and storage
